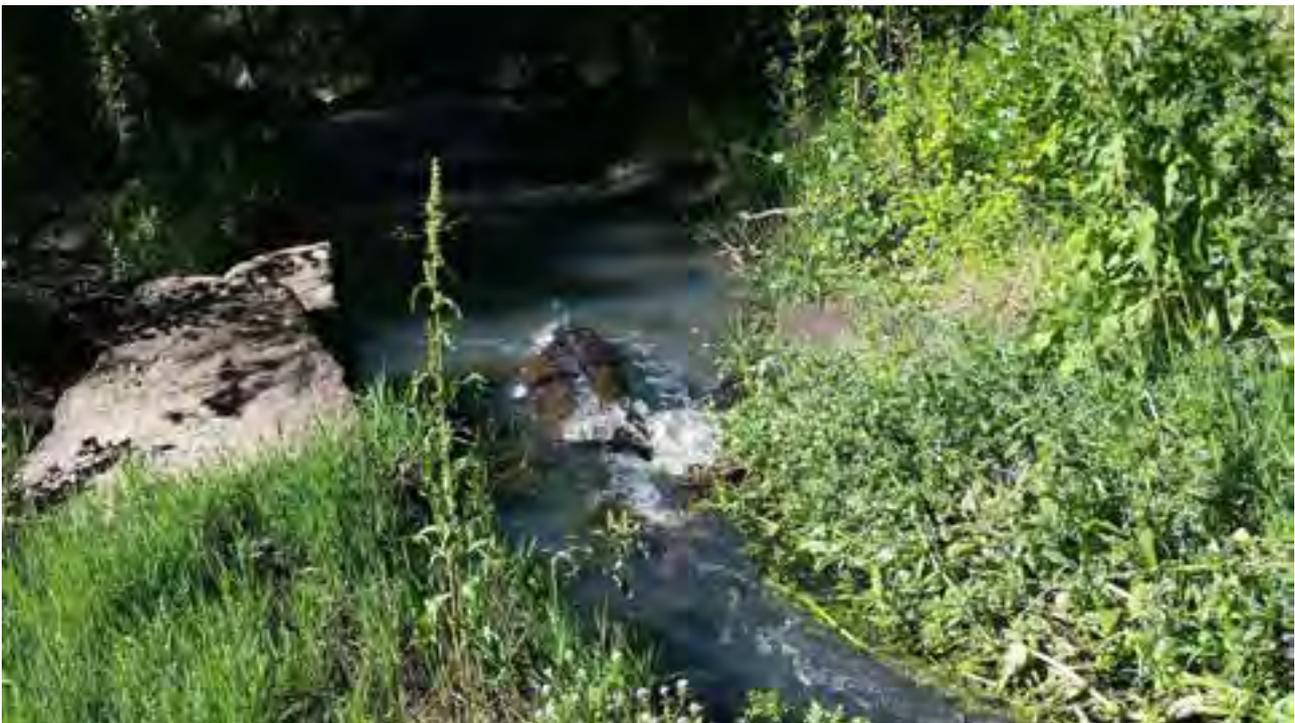
A head-cut was identified in Castle Creek immediately upstream of the confluence with Huon Creek. The head cut has been armoured with concrete and rock (Figure 4-39).

Figure 4-39 Head cut that has been armoured with concrete.

- The extent and nature of erosion within this reach requires further investigation. The informal bed grade control structure near the confluence with Huon Creek will likely fail in the short to medium term. Once failure has occurred, the head-cut will become active and re-initiate bed deepening within this reach. This has the potential to liberate large volumes of sediment and undermine infrastructure upstream of the head-cut.

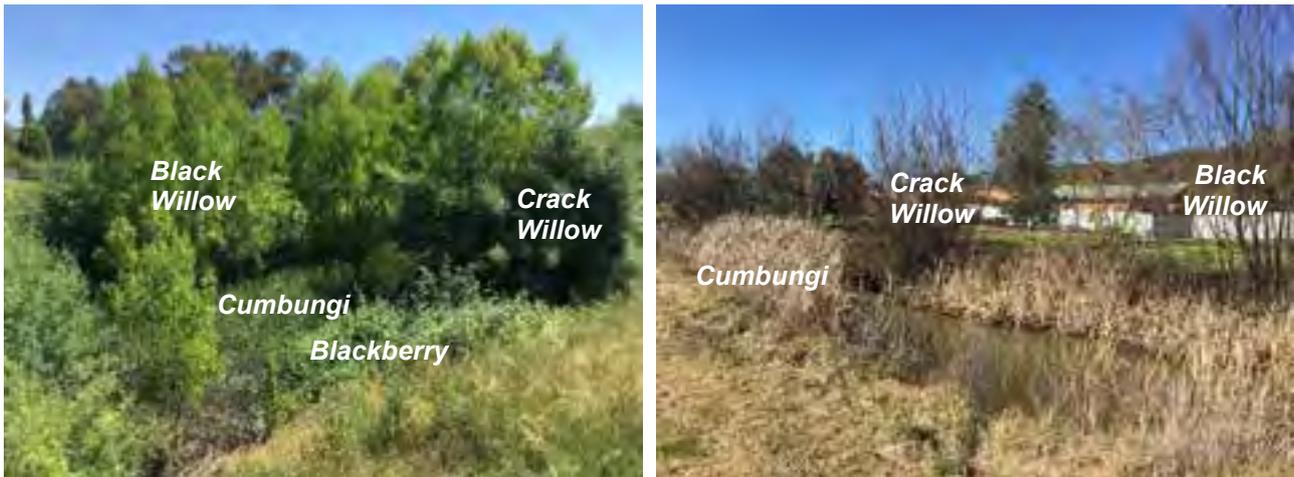
Figure 4-40 Creek line upstream in summer (left) and downstream in winter (right) of Yarralumla Drive.

- The section of this reach upstream of Yarralumla Drive is solidly infested with woody weeds. Condition is very poor and can only improve with weed control and replacement with native revegetation.

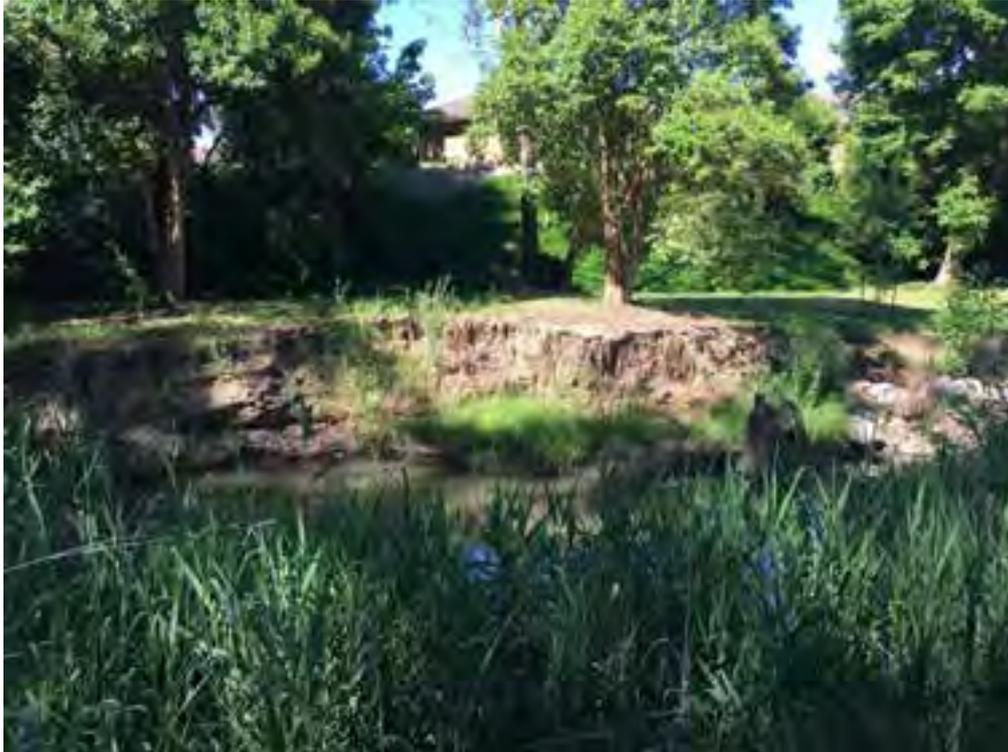
Bank instabilities are common within this reach. Erosion was often associated where the surrounding floodplain surface is mown to the top of bank and there is an absence of woody riparian vegetation (freehold land, Figure 4-42). Rock beaching was observed in a discrete location.

Figure 4-42 Erosion is evident in an area where the grass is mown to the top of the bank.

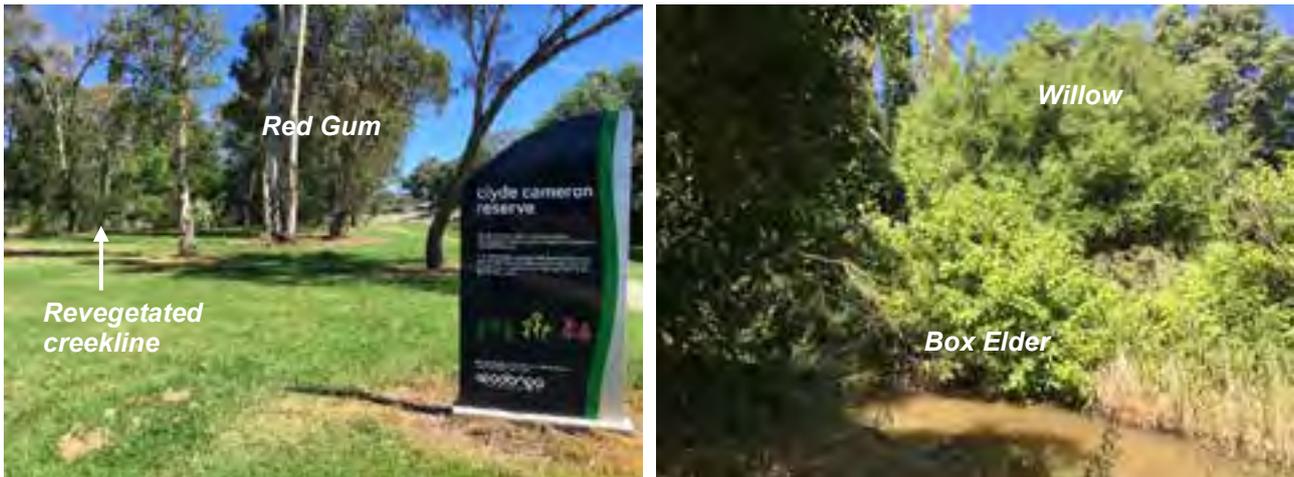
The right bank, in contrast, is in very poor condition with tree and shrub weeds dominating the majority of the bank's length. There is limited floodplain along most of the right bank and freehold properties extend close to the creek bank. The creek pushes up to the floodplain margin along sections of the right bank and these steep high banks are by nature more difficult to maintain and are often infested by woody weeds. There are some small floodplain pockets off the right bank that are kept clear with mowing, however, the woody weed species are still abundant on the bank and exotics are also being planted.

Figure 4-43 Left bank managed parkland, weed infested right bank.

- The right bank is in very poor condition and will remain so unless weed control and native revegetation works are undertaken.
- The management regime on the right bank is compromising the weed management works on the left bank as weeds are providing a constant source of propagules, either by wind (e.g. Box Elder, Ash, Black Willow), during flooding (e.g. Crack Willow, Tradescantia) or via other vectors (e.g. birds). A co-ordinated weed management program is required to ensure future works are not compromised.

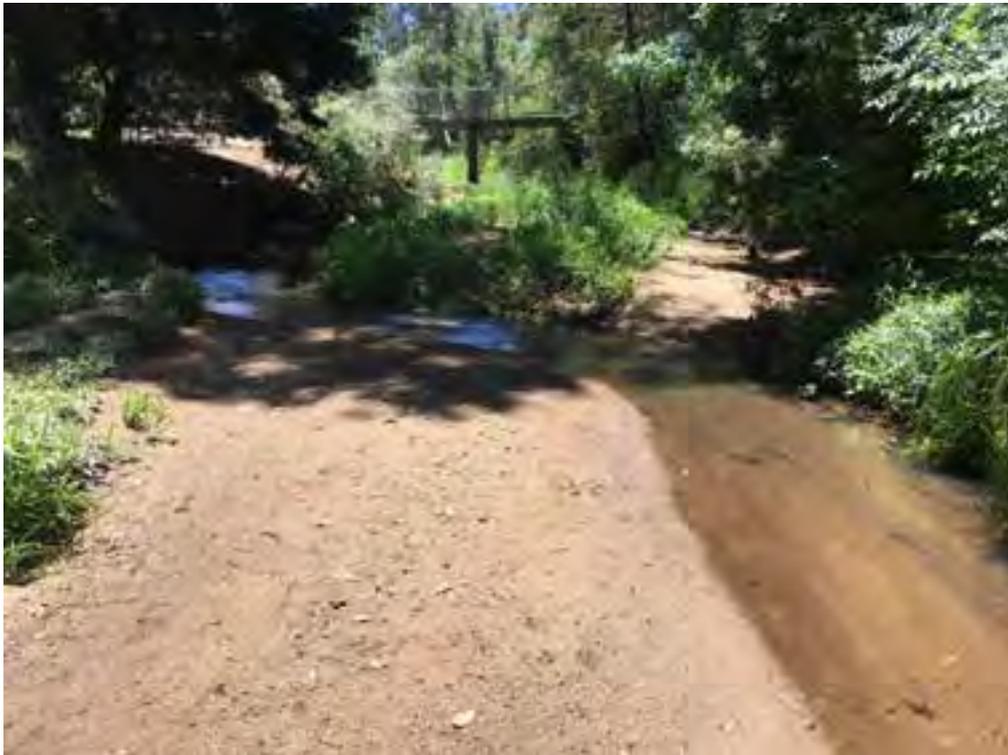
Between Brockley Street and Lawrence Street, large sand deposits were evident (Figure 4-44). The sand has deposited across the entire channel bed, forming a uniform bed profile with a low flow channel meandering through the sand.

Figure 4-44 Looking downstream at a large sand deposit in House Creek.

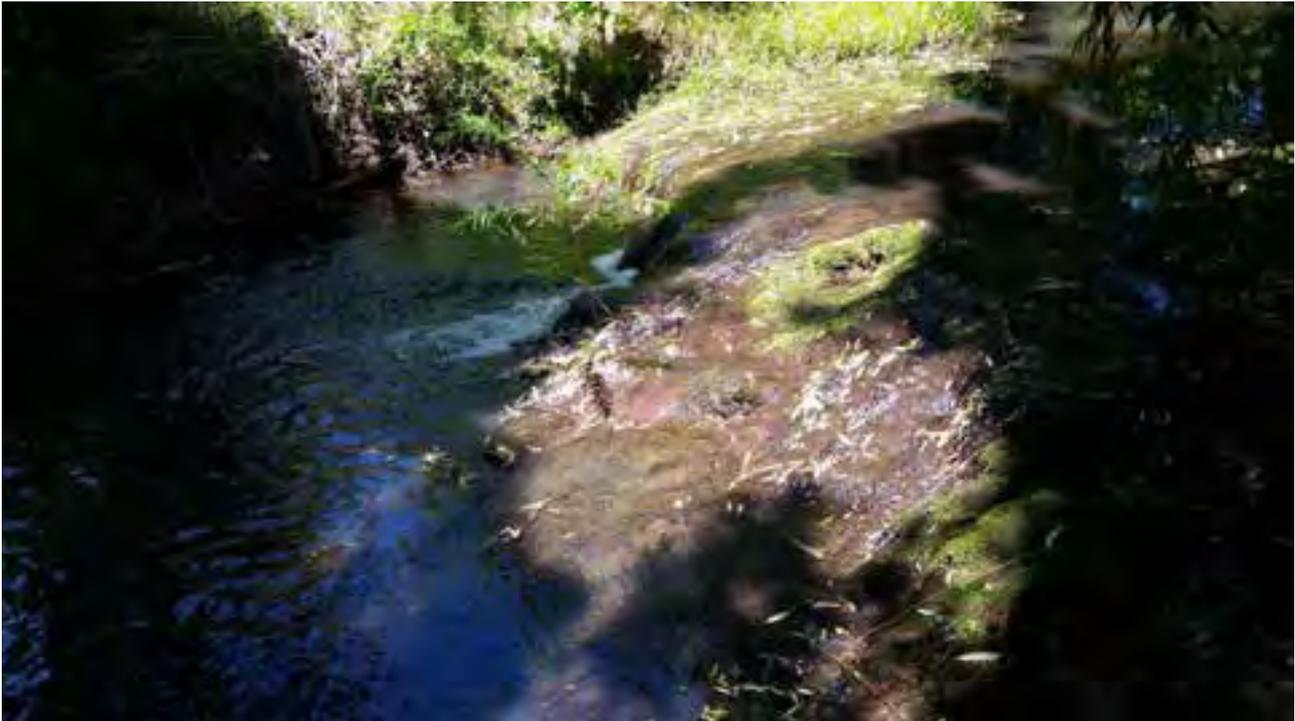
A number of head-cuts were identified a short distance upstream of Melbourne Road indicating that the reach is undergoing deepening (Figure 4-45). The head-cuts were all stabilised by willow roots or informal rock chutes.

Figure 4-45 Head-cut in House Creek, approximately 50 metres upstream of Melbourne Road, that is currently stabilised by willow roots.

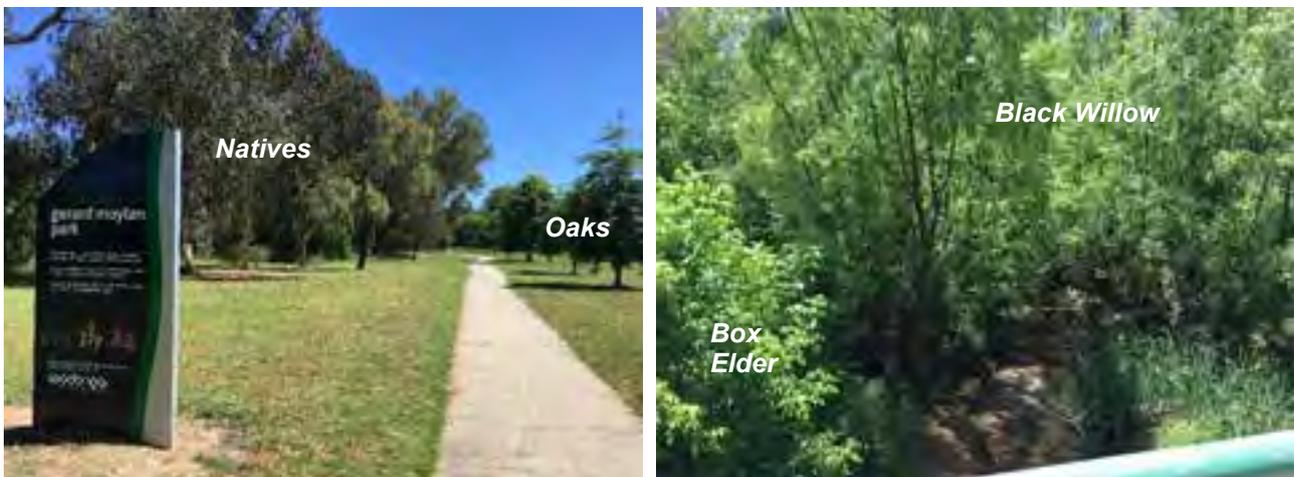
Figure 4-46 Semi-formal parkland floodplains, Black Willow infested channel downstream from Brockley Street.

Willow (Weeping and Black) and Box Elder (Figure 4-46, right) are the more prevalent weeds within this middle section of the reach. Both the Black Willow and Box Elder are spreading from wind borne seed and colonising the banks and unmown verges. Black Willow in particular will colonise moist sand bars within the channel

(Figure 4-46, right) and have the potential to cause substantial blockages, reduce channel capacity and deflect flow.

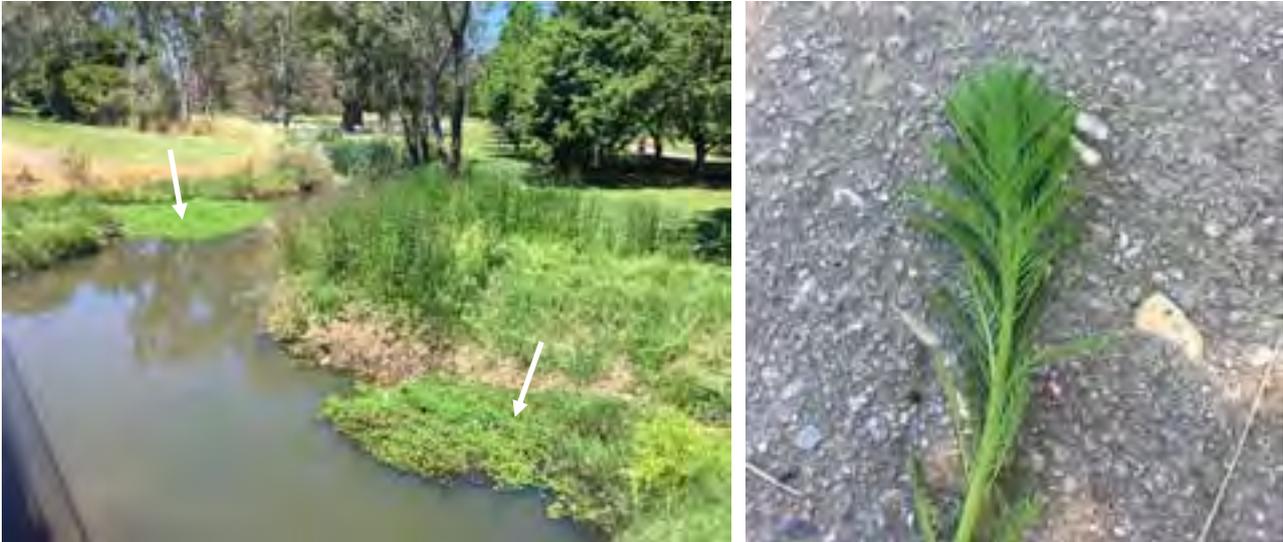
Two infestations of the invasive perennial aquatic weed, Parrot's Feather (*Myriophyllum aquaticum*) were observed in slight backwaters, just upstream of Lawrence Street, within Les Stone Park (Figure 4-47).

Figure 4-47 Parrots Feather infestations upstream of Lawrence Street, closeup of stem and leaves.

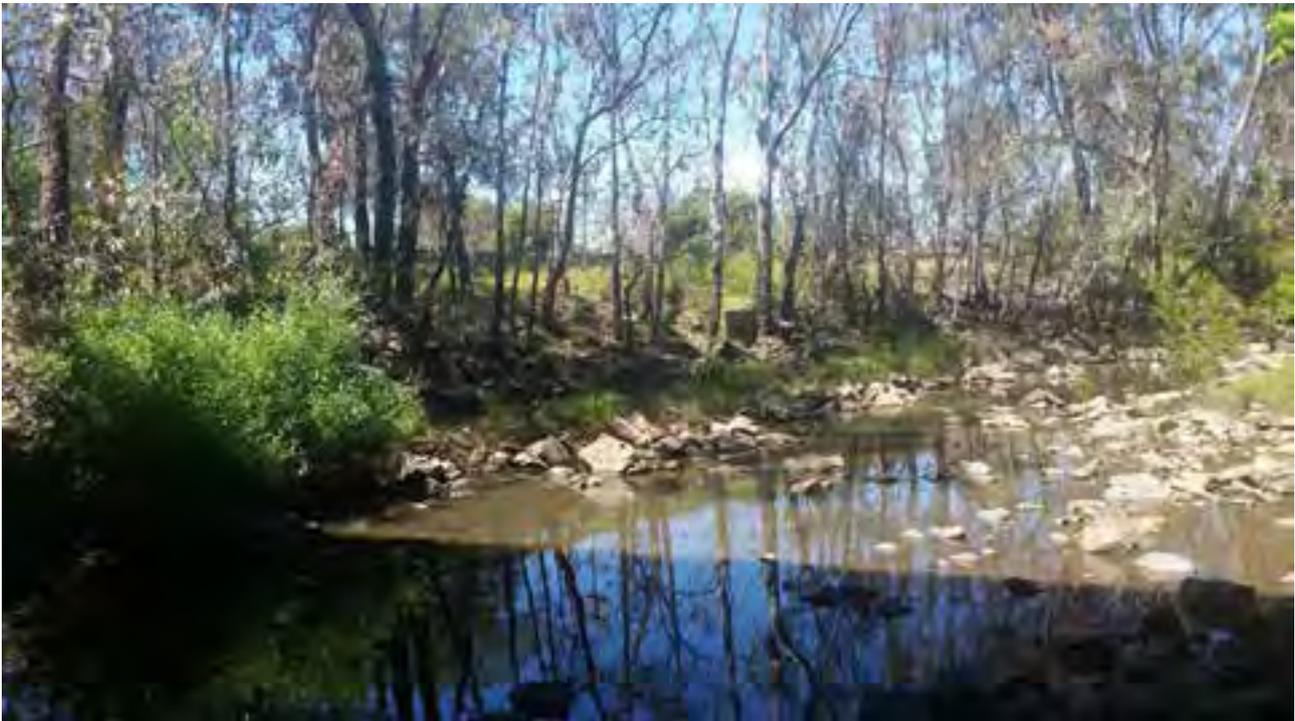
Approximately 200 metres upstream of the Hume Freeway, the channel becomes deeper and wider and has been lined with a substantial amount of quarry rock on both the bed and banks through to the confluence with Wodonga Creek (Figure 4-48). It is not clear why the rock has been placed over this large extent, however it is assumed that the rock has been used to mitigate channel deepening and bank erosion and to protect the Hume Freeway bridge crossing.

Figure 4-48 Rock lined channel of House Creek located under the Hume Freeway.

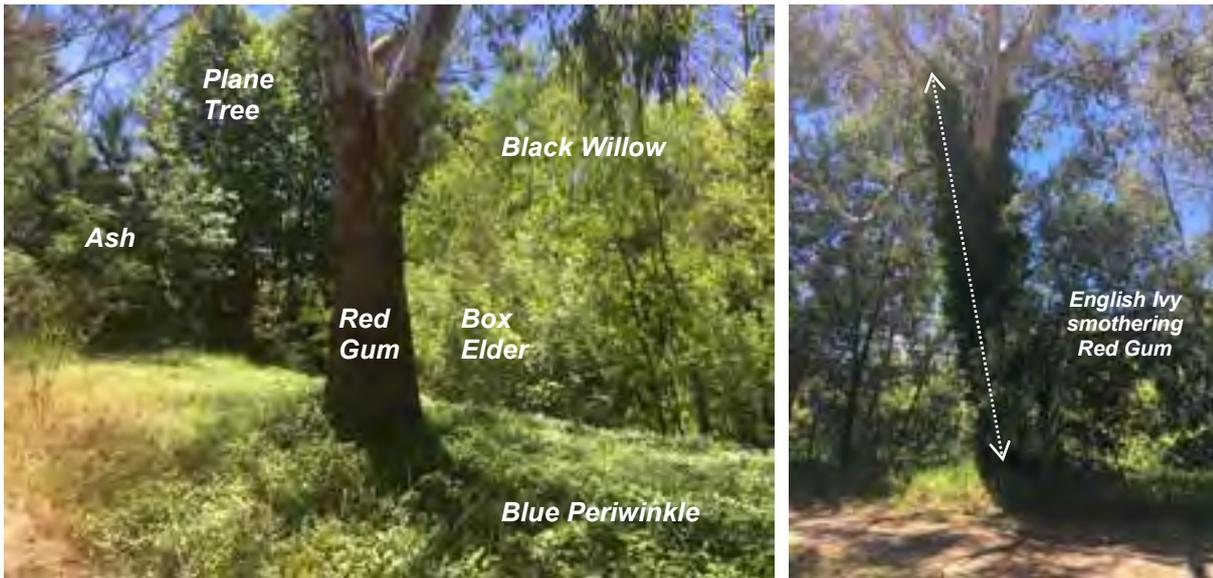
This reach is extremely weedy from Melbourne Road, through Phil Locke Adams Park and Felix Grundy Park to the middle of Belvoir Park. Phil Locke Adams Park is less formal than the Parks upstream and the creek channel is severely infested with woody weeds, particularly Black Willow, Ash, Box Elder and Poplar. There is a large infestation of Blue Periwinkle on the ground layer within Phil Locke Adams Park and English Ivy is threatening to smother mature Red Gums (Figure 4-49).

Figure 4-49 House Creek weeds surrounding Red Gums within Phil Locke Adams Park.

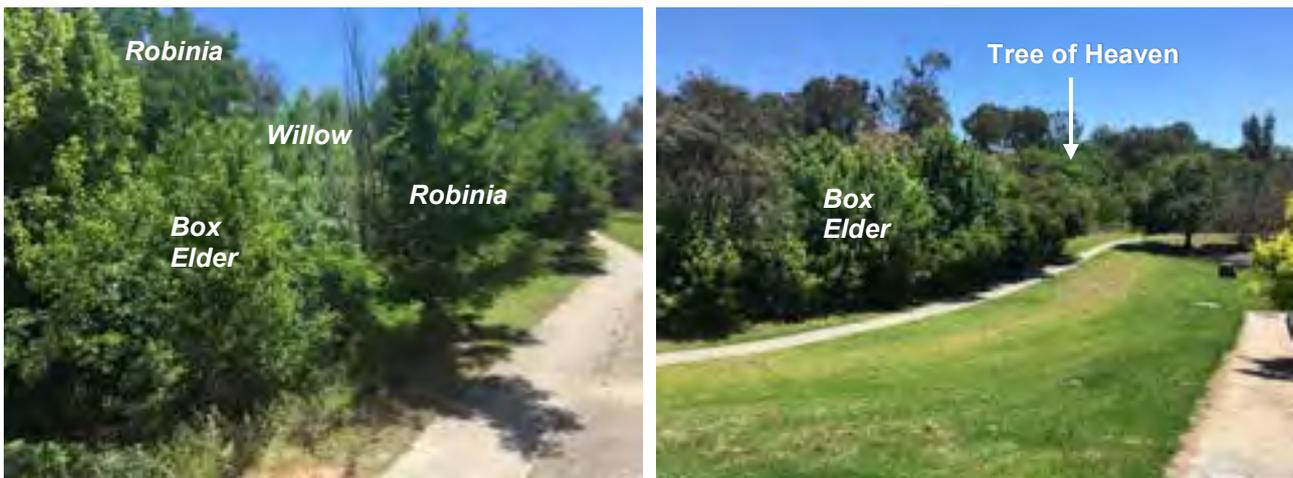
Figure 4-50 Heavily infested channel downstream of Forrest Mars Avenue, Felix Grundy Park with Tree of Heaven infesting hillslope adjacent to abattoir.

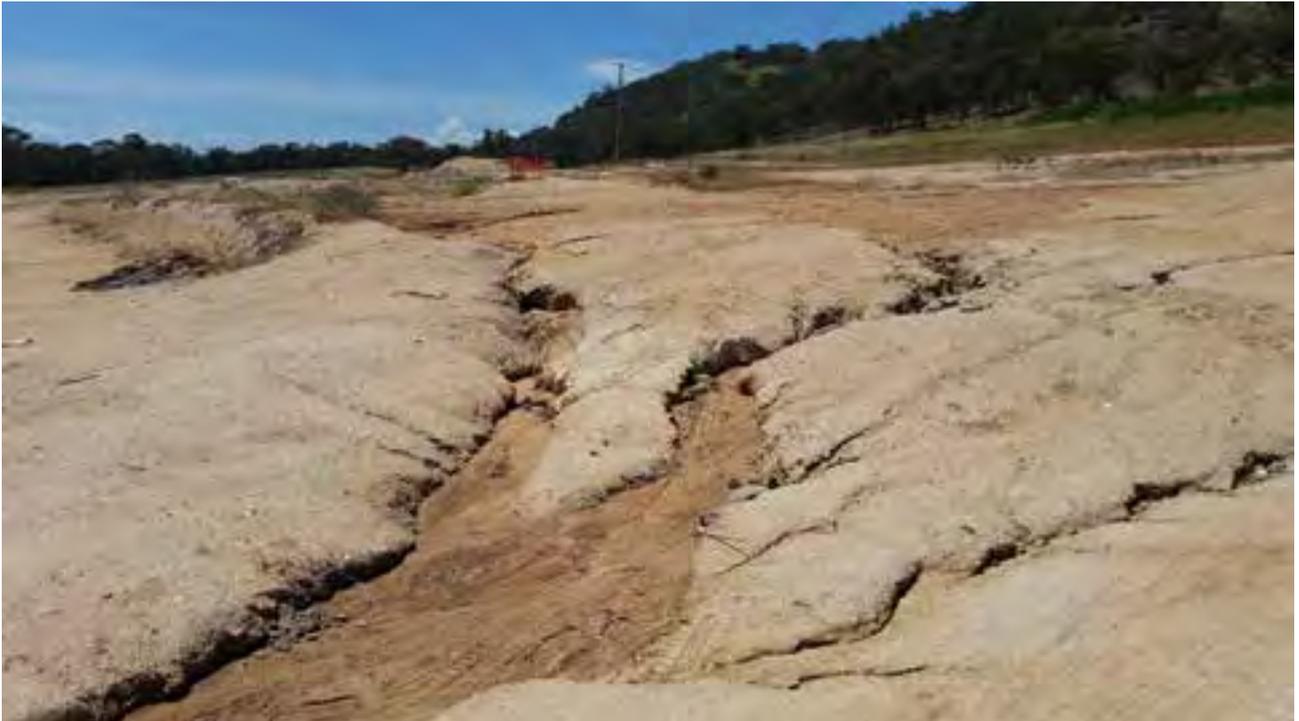
White Box Rise has undergone significant development over the last ten years and development is still occurring. During the site inspection, it was noted that the sediment management on the White Box Rise development area was poor to non-existent, with rill erosion present across the area under development

Figure 4-53 Rill erosion has occurred at the White Box Rise development.

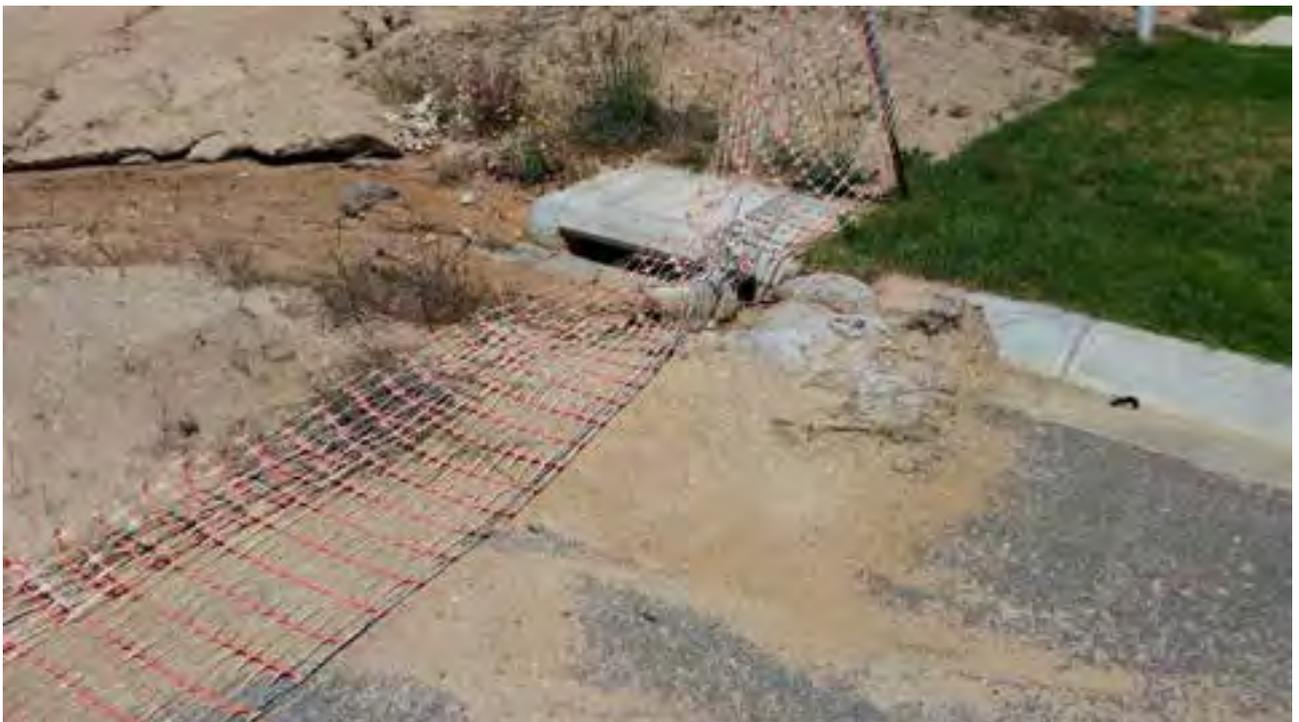
Figure 4-54 Sand bags being used to direct sediment into a side entry pit at the existing development of White Box Rise.

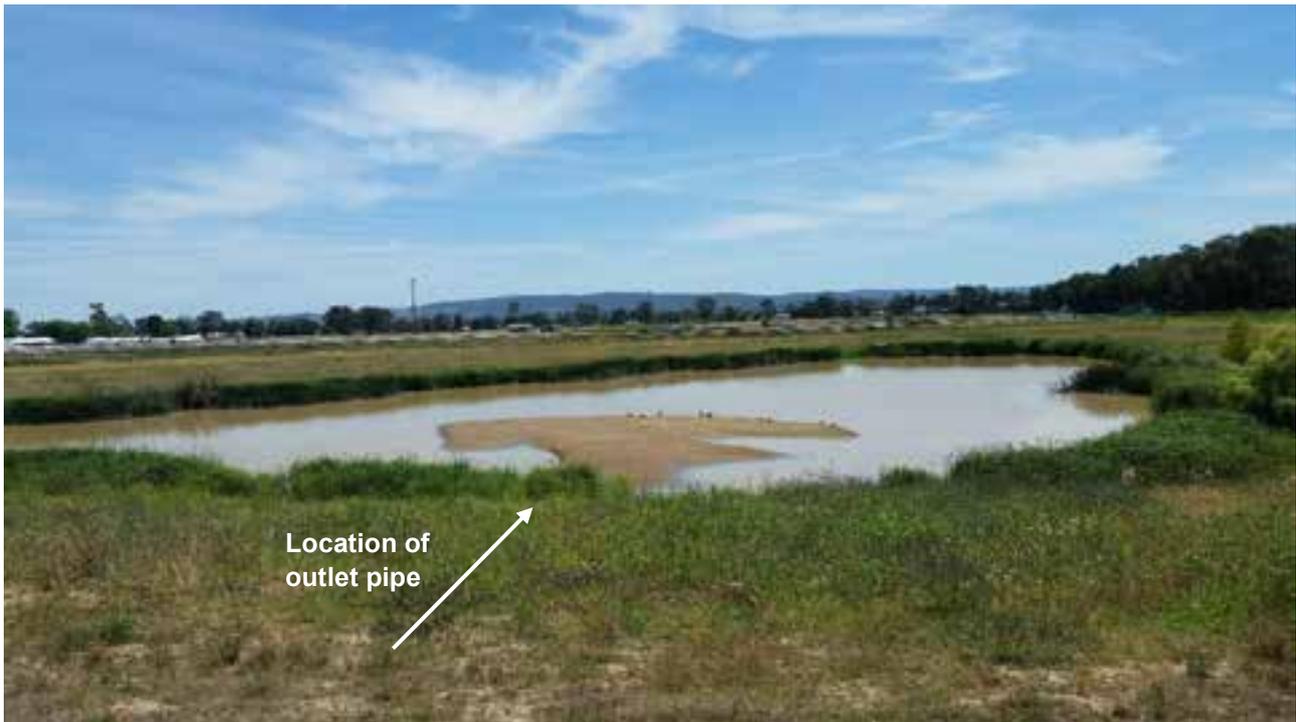
It is assumed that the stormwater from the White Box Rise development is directed to the four treatment ponds at the Wodonga Racecourse and Recreation Reserve. A significant volume of deposition is evident within the upstream pond immediately downstream of the inlet (Figure 4-55).

Figure 4-55 Significant volume of sediment in the upstream pond at Wodonga Racecourse and Recreation Reserve.

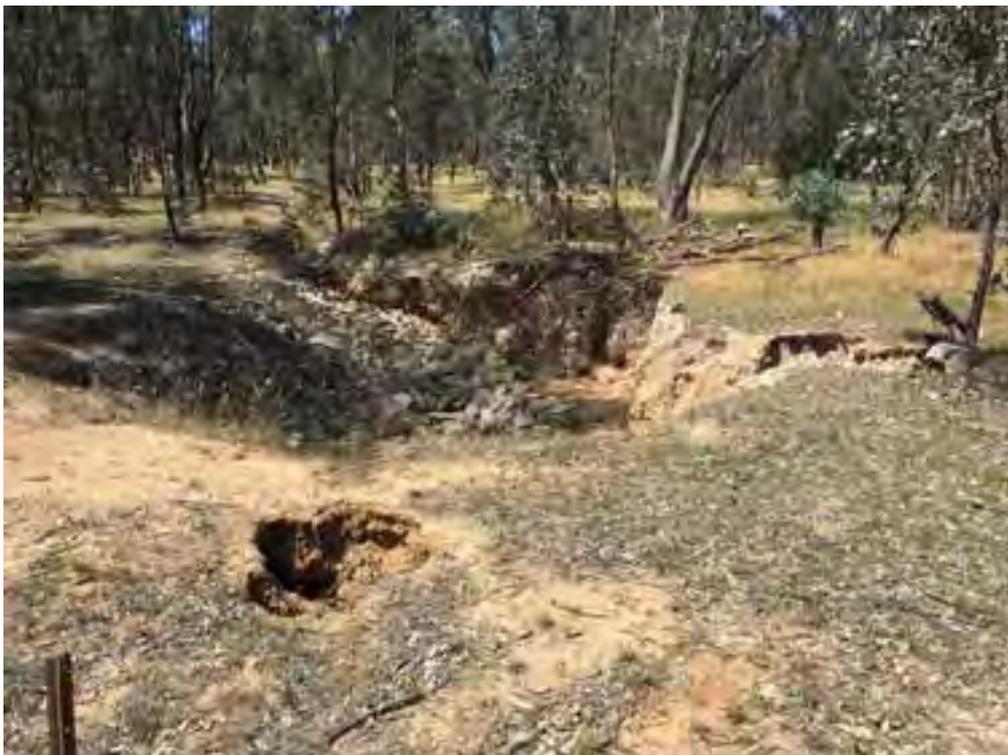
A small channelised tributary flows through woodlands along the western edge of White Box Rise. Erosion is present immediately upstream of the Victoria Cross Parade culvert crossing within this tributary (Figure 4-56). The erosion incorporates bed deepening, associated bank erosion and tunnel erosion within dispersive soils and may have been triggered by the construction of the culvert crossing. Rock armouring has been placed within the channel, however the erosion is occurring adjacent to the placed rock.

Figure 4-56 Looking upstream at erosion in one of the tributaries of Jack-in-the-Box Creek, upstream (south) of Victoria Cross Parade.

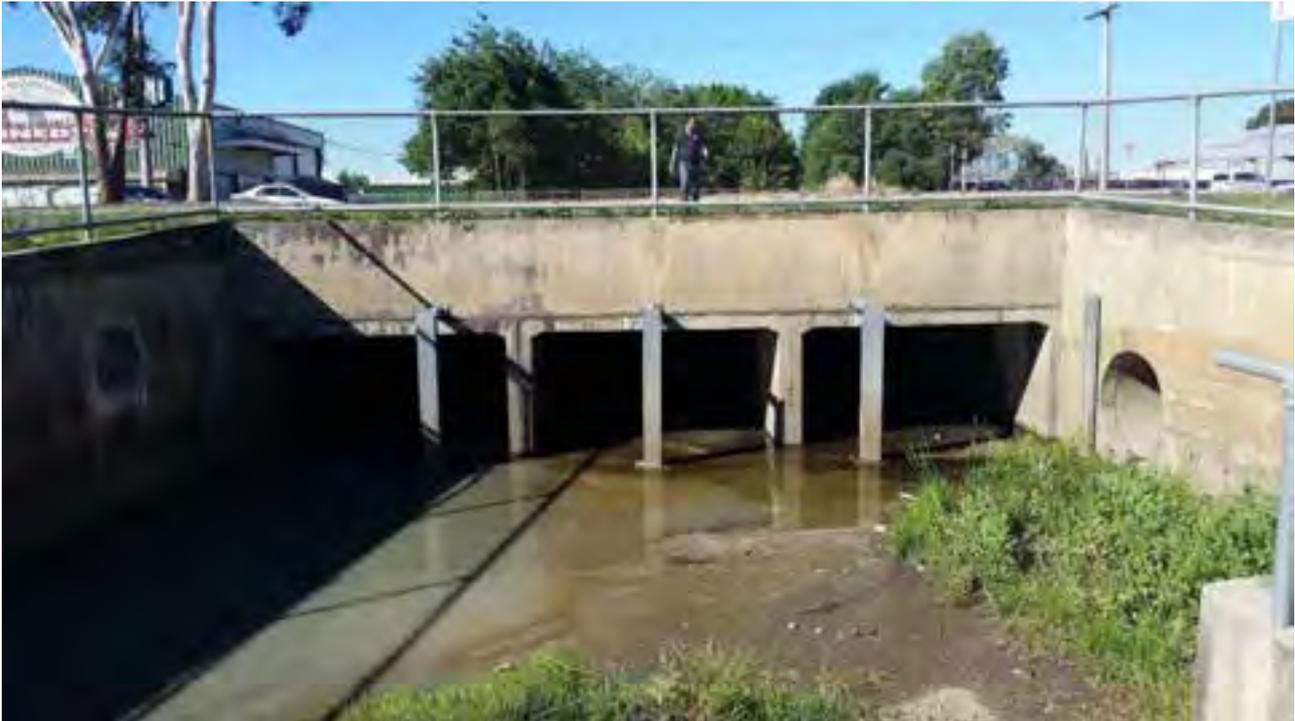
The underground pipe discharges into an open junction pit at Osburn Street. The Junction pit also receives stormwater from the east and west. At the time of the inspection the discharge from the Jack-in-the-Box Creek pipe was milky white in appearance (Figure 4-58).

Figure 4-58 Junction pit at Osburn Street. Note the milky water to the left of the junction pit.

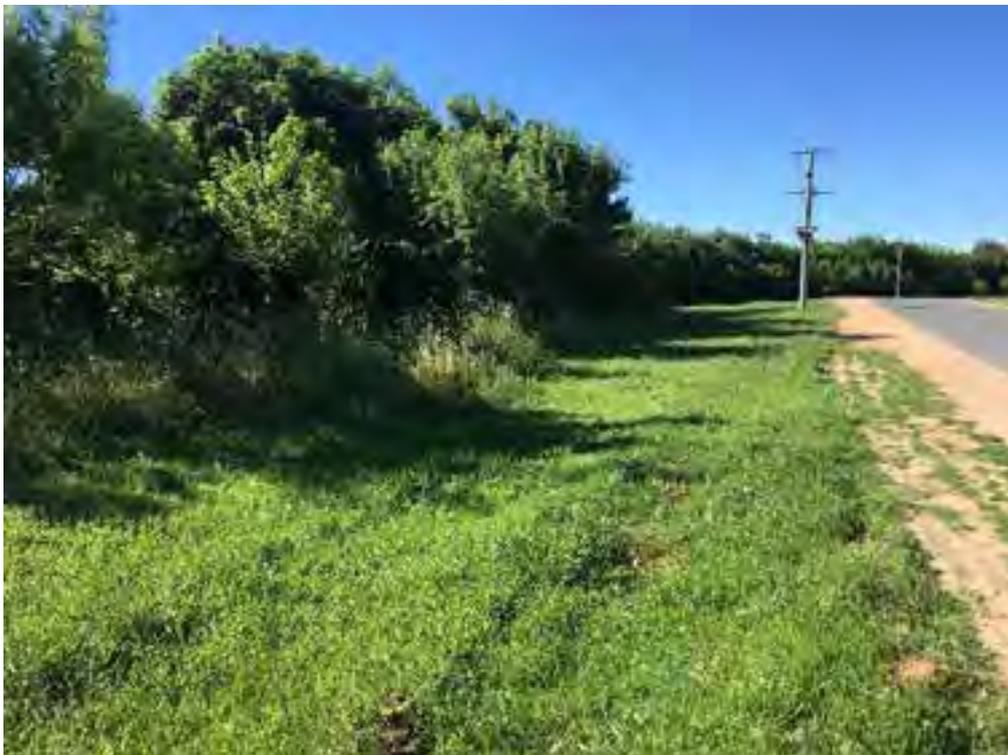
The woody riparian vegetation from Osburn past Kendall Street to the old railway line is almost exclusively exotic (Figure 4-59). There are patches of Red Gum canopy trees close to the old rail line and on the downstream side of the freeway to Wodonga Creek (Figure 4-60), however these patches are infested with Willow, Blackberry and Privet.

Figure 4-59 Woody weed infested riparian zone adjacent to Kendall Street.

- The vast majority of the riparian zone from Osburn Street to the railway line is heavily infested with woody weeds and is in very poor condition. This section will remain in poor condition under the current management regime and requires extensive weed control and revegetation to improve conditions.

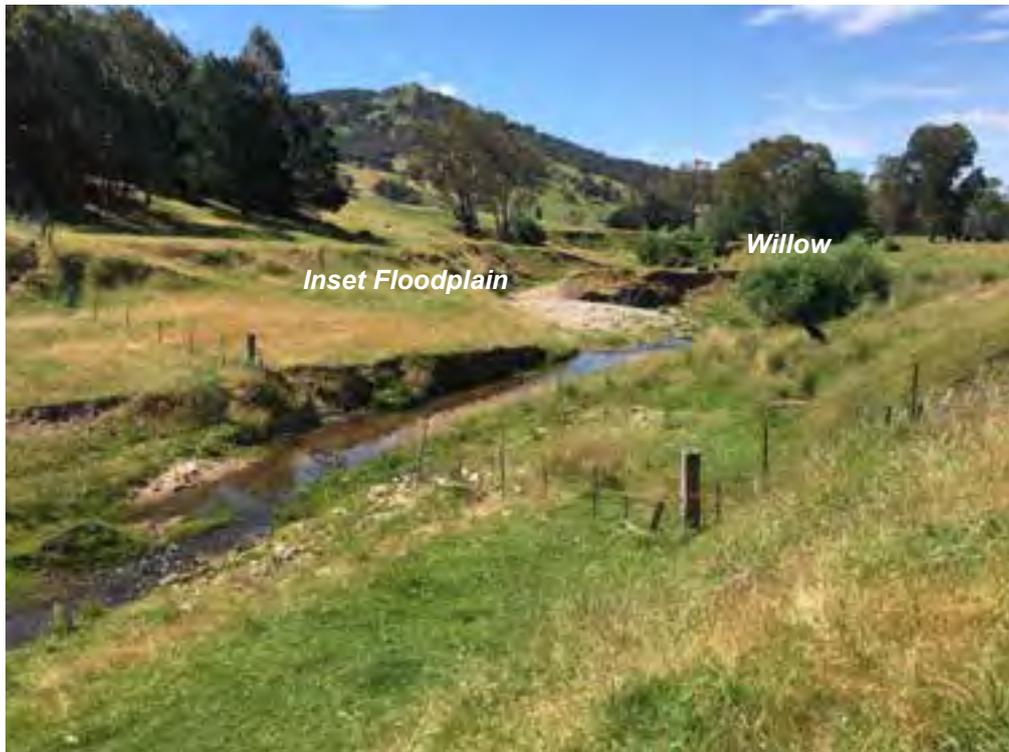
surface levels exist along this reach (Figure 4-62). Additionally, bed deepening within the primary channel has likely triggered deepening within the tributary network (Figure 4-63). It is probable that bedrock impingements limit the upstream propagation of bed deepening in the upper section of the creek and tributary network.

Figure 4-62 Incised channel of Middle Creek showing unrestricted stock access to the channel.

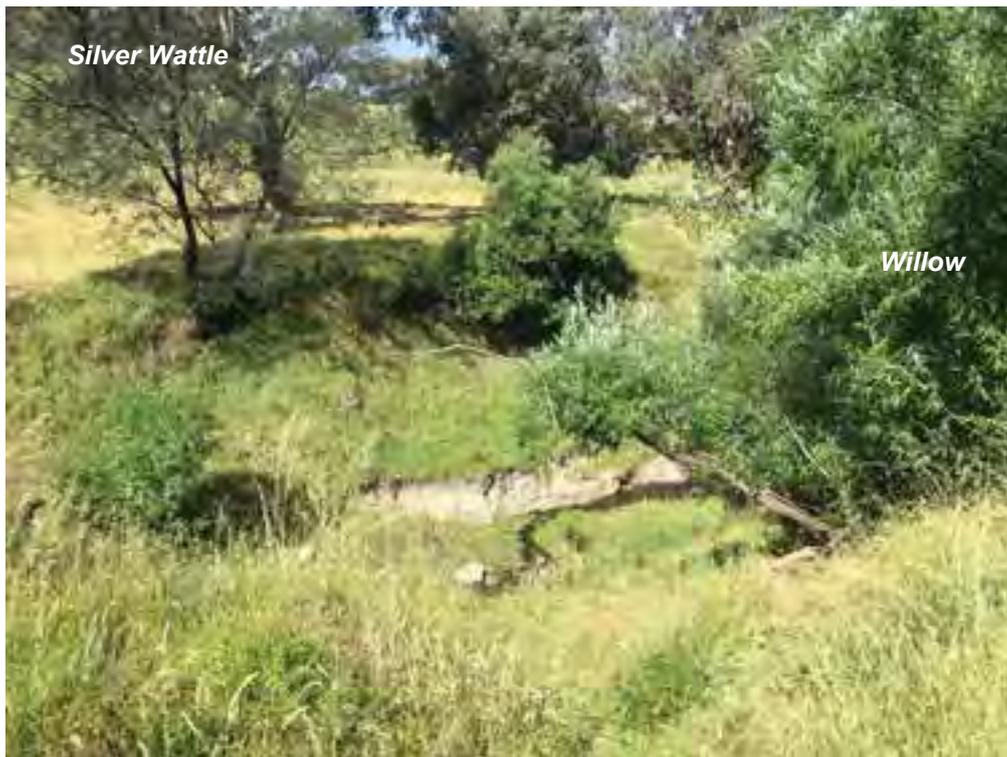
Figure 4-63 Silver Creek, a tributary of Middle Creek, has deepened, likely in response to deepening within Middle Creek.

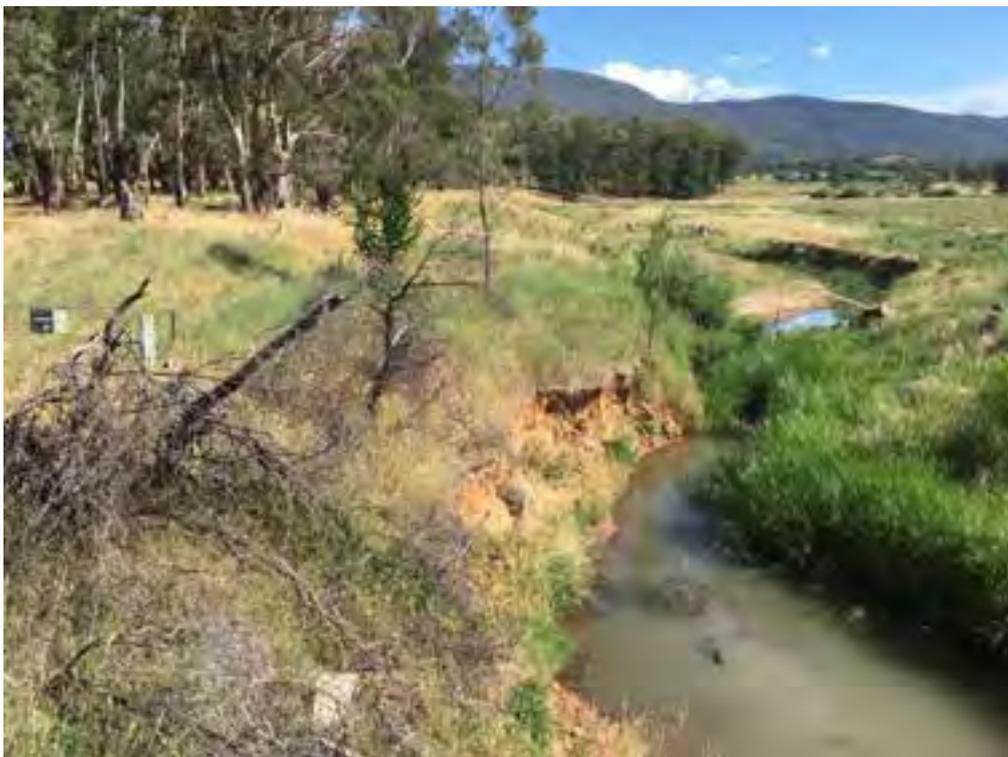
Figure 4-64 Bank erosion occurring on the outside bend and deposition occurring on the inside of the bend.

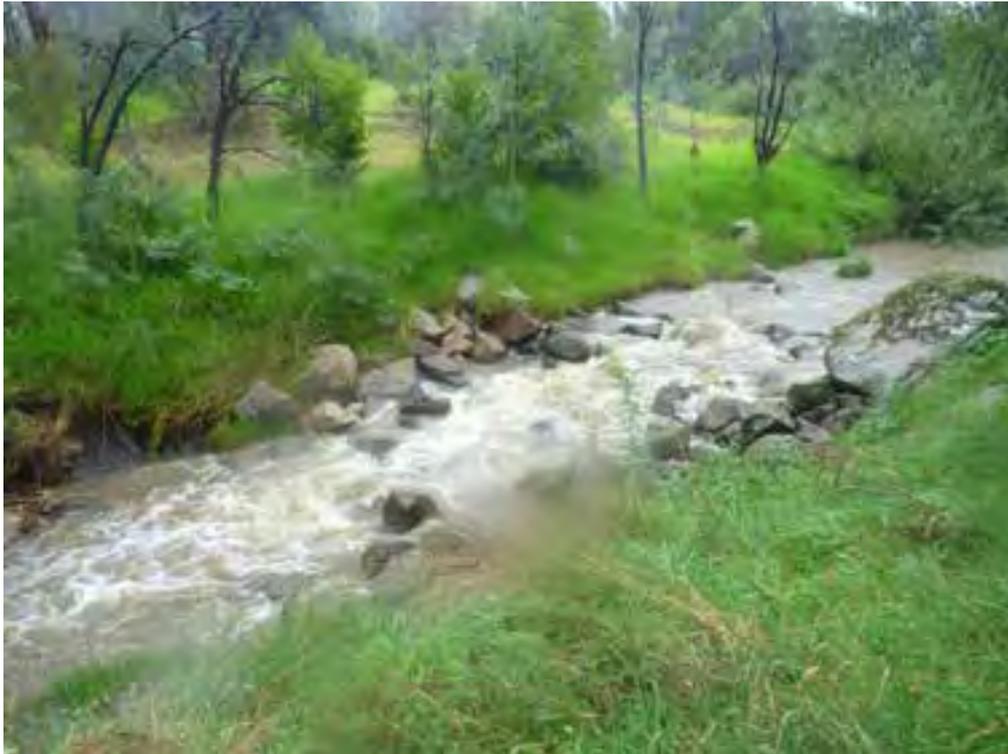
A series of rock chutes (bed grade control structures) are present downstream of Frederic Street Road (Figure 4-65). These rock chutes provide an important function in maintaining channel stability within this reach.

Figure 4-65 A rock chute situated in Middle Creek downstream of Frederic Street Road. The rock chute is providing an important function in maintaining channel stability.

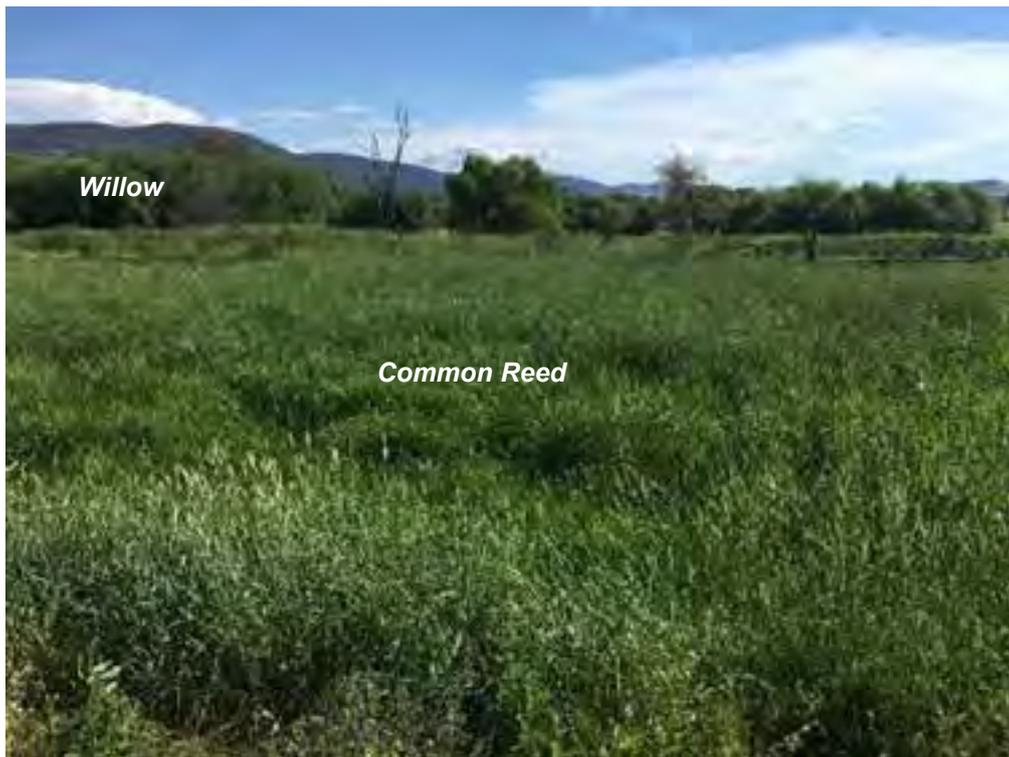
The vegetation within this reach would once have been a Floodplain Riparian Woodland (EVC56), which characteristically are dominated by Red Gums. In its current form, this reach is highly modified with willows now dominating the riparian zone (Figure 4-66, Figure 4-67). Common Reed is also abundant within and surrounding the creek channel where grazing is absent (Figure 4-66).

Figure 4-66 Willows and Common Reed dominate the floodplain upstream of the Kiewa Valley Highway.

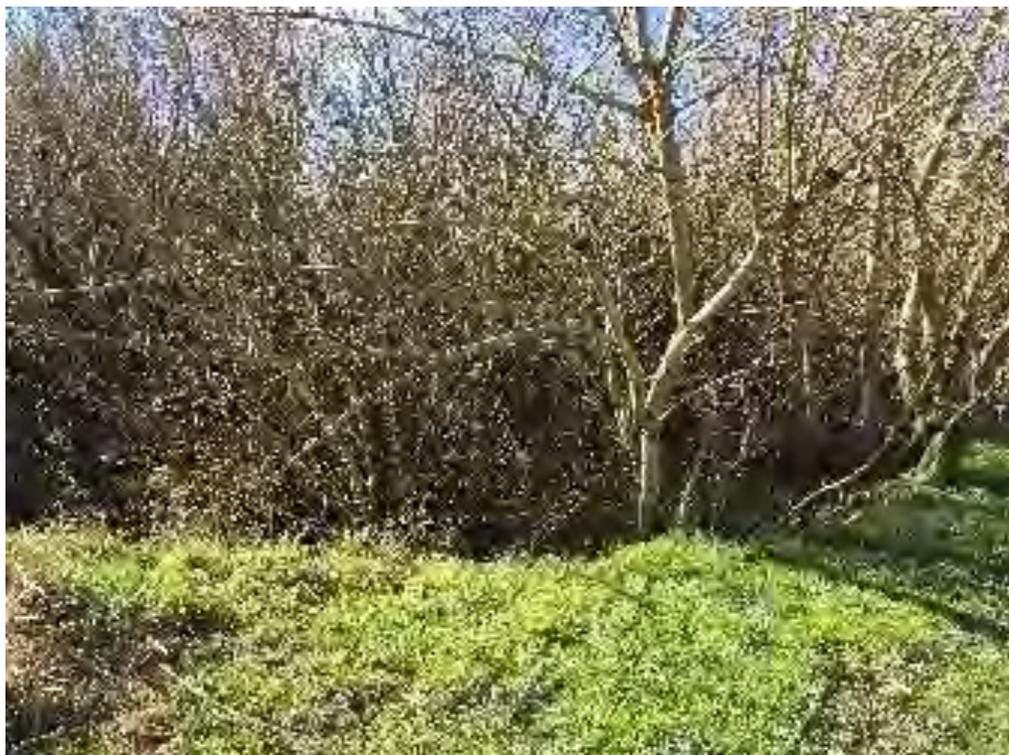
Figure 4-67 Willows occupy the channel downstream of Whytes Road.

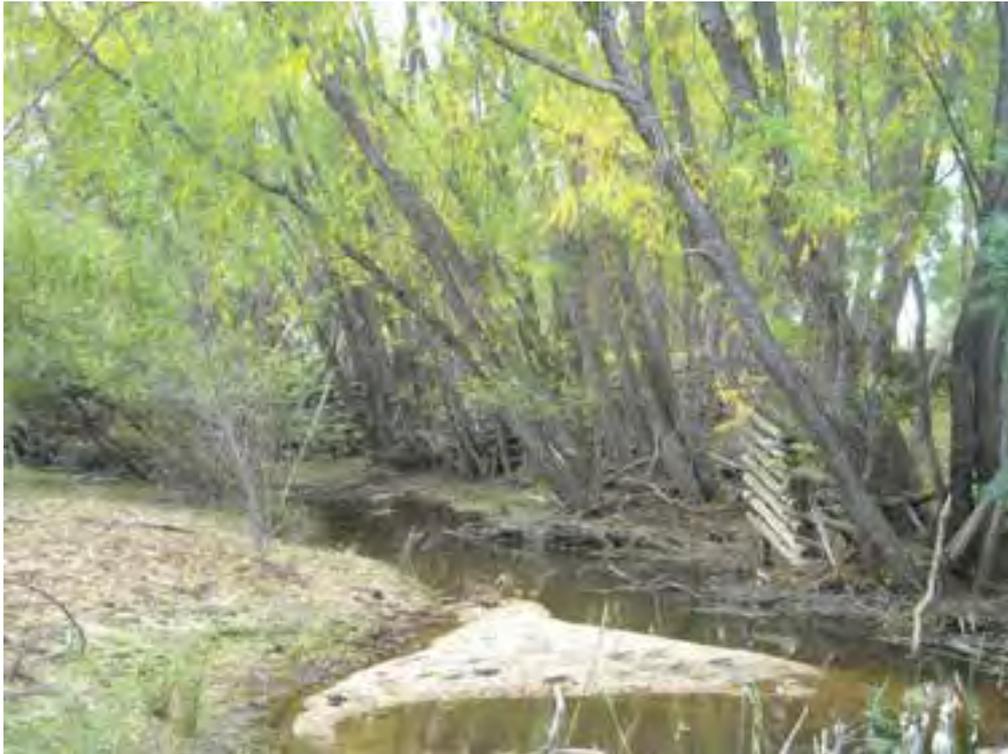
Figure 4-69 Black Willow planted at the toe of the bank behind pile fields. Pile field works have frequently been implemented in conjunction with exotic vegetation plantings.

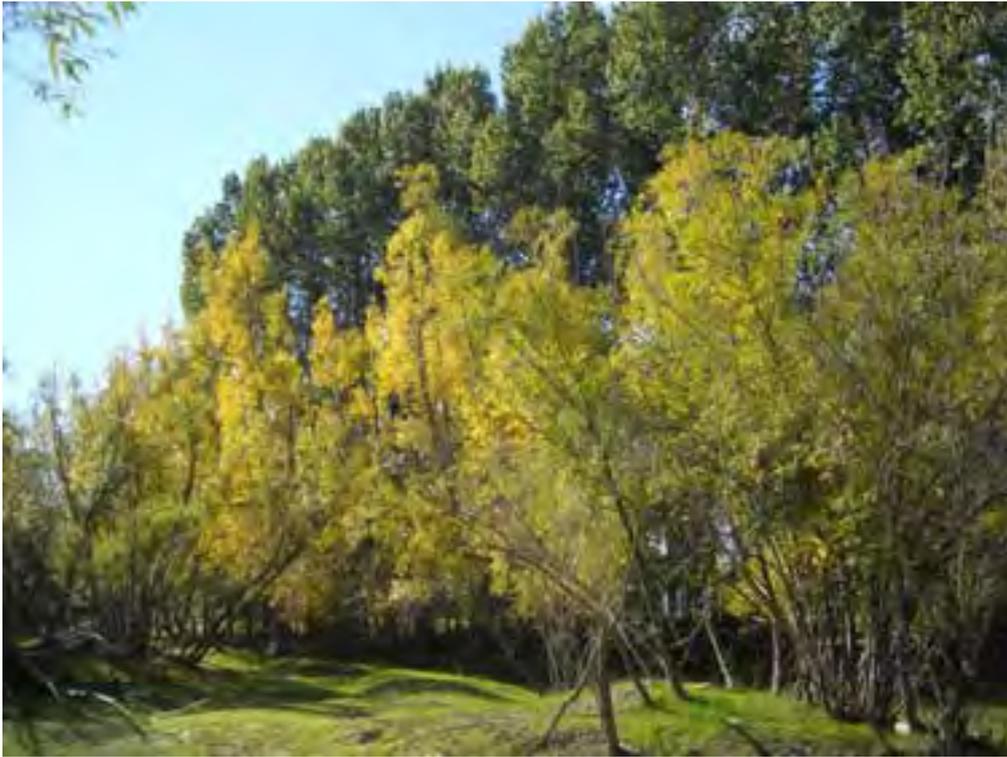
The exotic vegetation within this reach is dominated by Willow and Poplar species (Figure 4-70) with Black Willows, Crack Willows the dominant species. In a number of locations willows are growing within the channel, both as individuals and in groups. The in-stream willows were largely juvenile Crack Willows and Black Willows and mature Black Willows. In some instances, the instream willows infestations are forming significant in-stream blockages. Juvenile Poplars are also present in-stream, however much less frequent.

Figure 4-70 Looking downstream at the right bank. This section of stream has been subject to exotic vegetation plantings to manage erosion. Crack Willow has been planted on the inset floodplain (in the foreground), Black Willow on the bank toe and poplars on the top of the bank.
