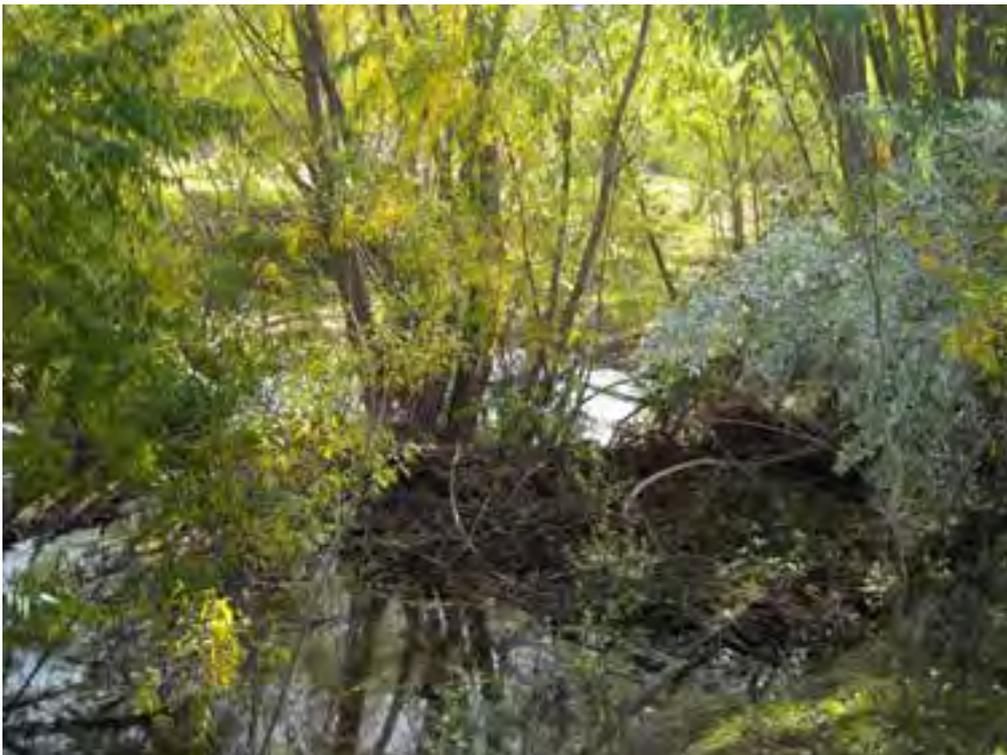
Figure 4-71 Looking downstream at Black Willow growing in the channel bed. In-stream willows are frequent within this reach.

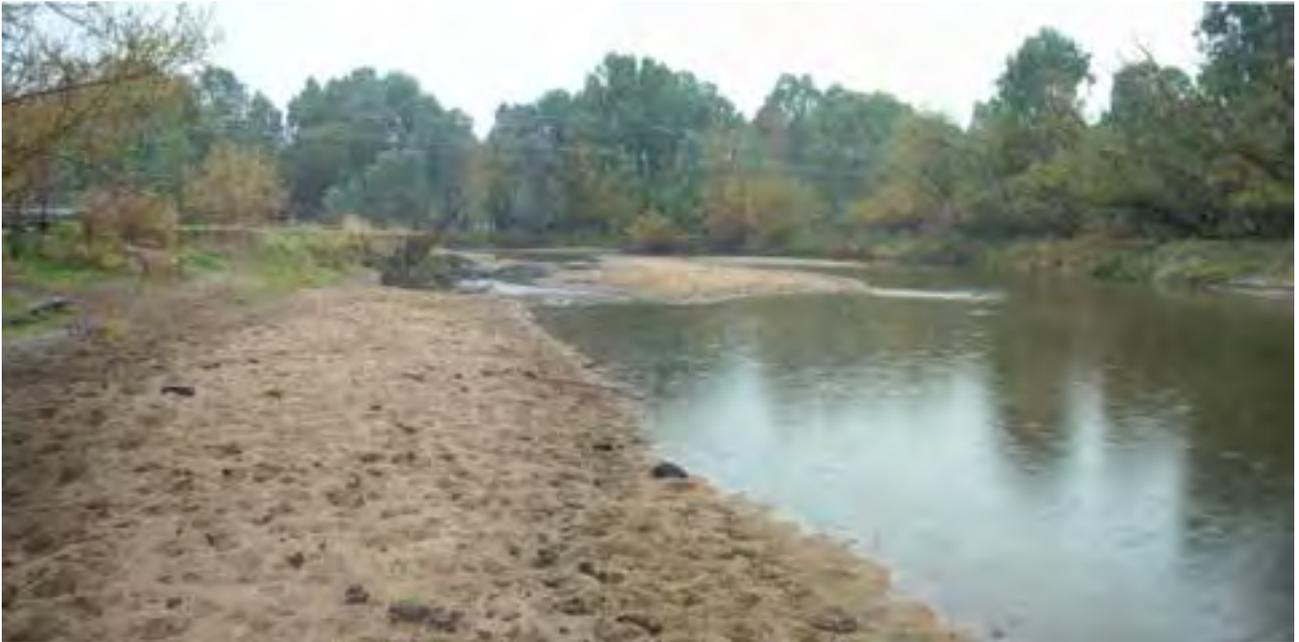
Historically, the Kiewa Reach appears to have both aggraded and degraded. Aggradation has occurred as a result of the liberation of large volumes of sediment from the upstream reaches. This sediment has deposited with the Yackandandah Creek and on the surrounding floodplain. The large volumes of sediment depositing in Yackandandah Creek may have contributed to the avulsive nature of the creek as it developed shorter, steeper and more hydraulically efficient flow paths. Sediment has also been conveyed through the reach to the Kiewa River where it is now a sand slug downstream of Yackandandah Creek (Figure 4-72).

Figure 4-72 Looking downstream within the Kiewa River, immediately downstream of the Yackandandah Creek – Kiewa River confluence.

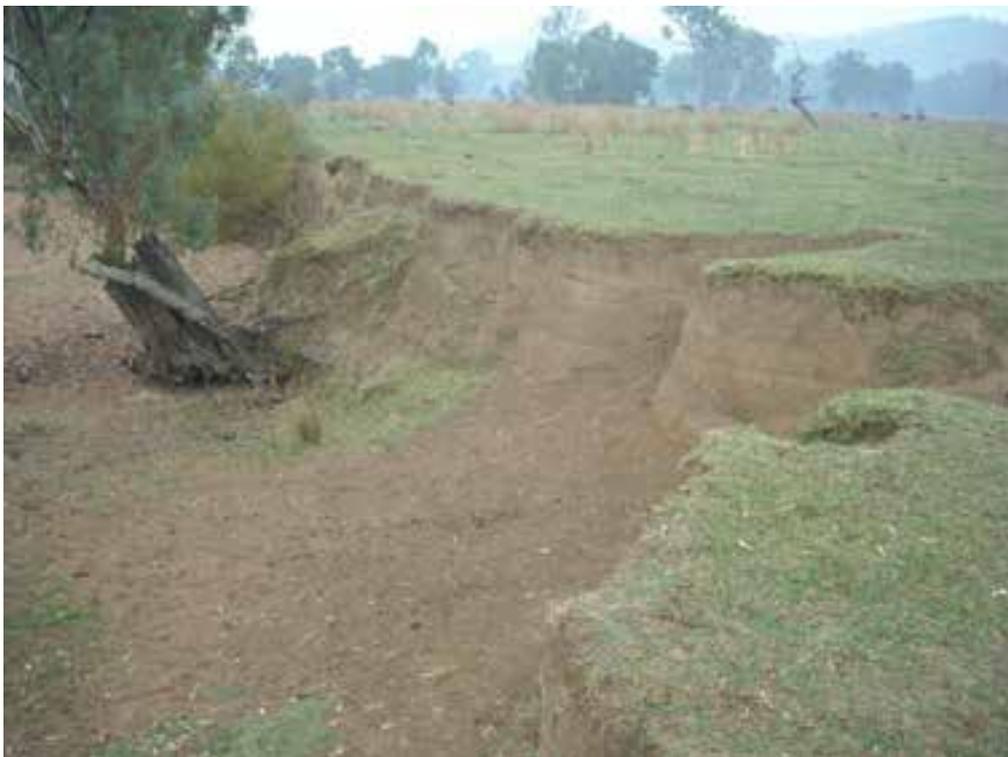
Stock have unrestricted access to the Yackandandah Creek throughout this reach and are impacting on the bank stability with access tracks present in numerous locations (Figure 4-73).

Figure 4-73 Stock have unrestricted access throughout the Kiewa Reach of Yackandandah Creek. Access tracks on the bank face are common through this reach.

- Unrestricted stock access is compromising the physical condition of the reach through the formation of tracks and limiting the regeneration of native woody species and Common Reed.

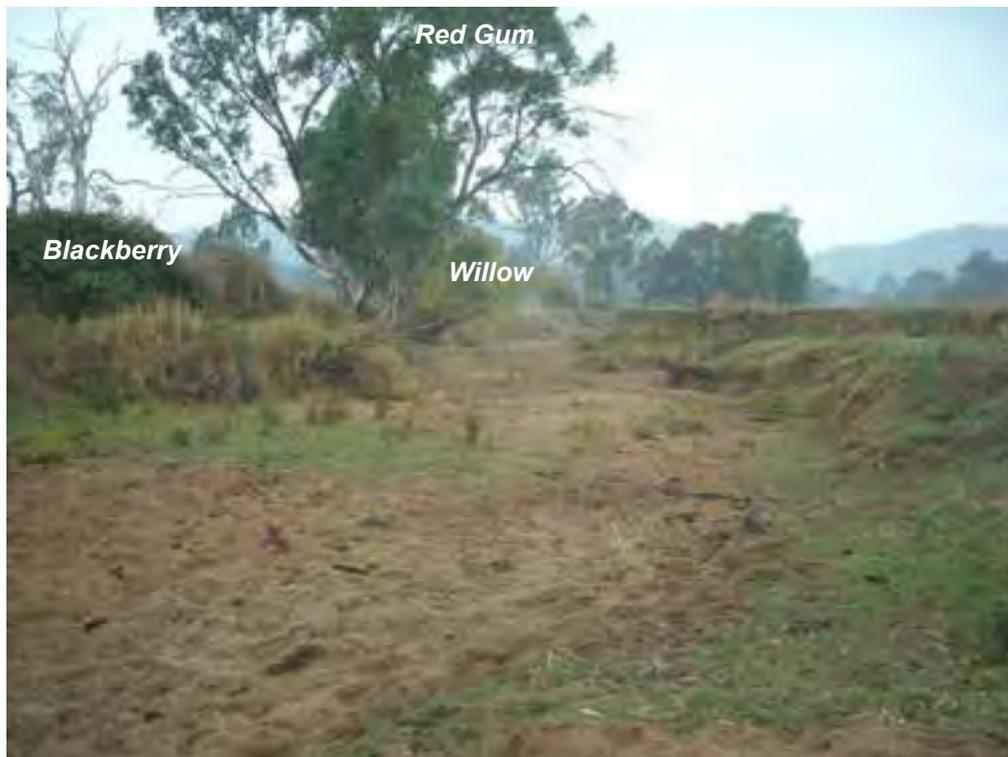
species including Pussy Willow, Crack Willow, Weeping Willow and Black Willows (Figure 4-74). The willows are present both in-stream and along the banks. Other exotic weed species present include Blackberry, Hawthorn, English Broom, Poplar, Bathurst Burr, Common Thorn Apple, Spear Thistle and Fleabane.

Figure 4-74 Typical section the Kiewa Reach, showing straight channel, scattered native and exotic vegetation.

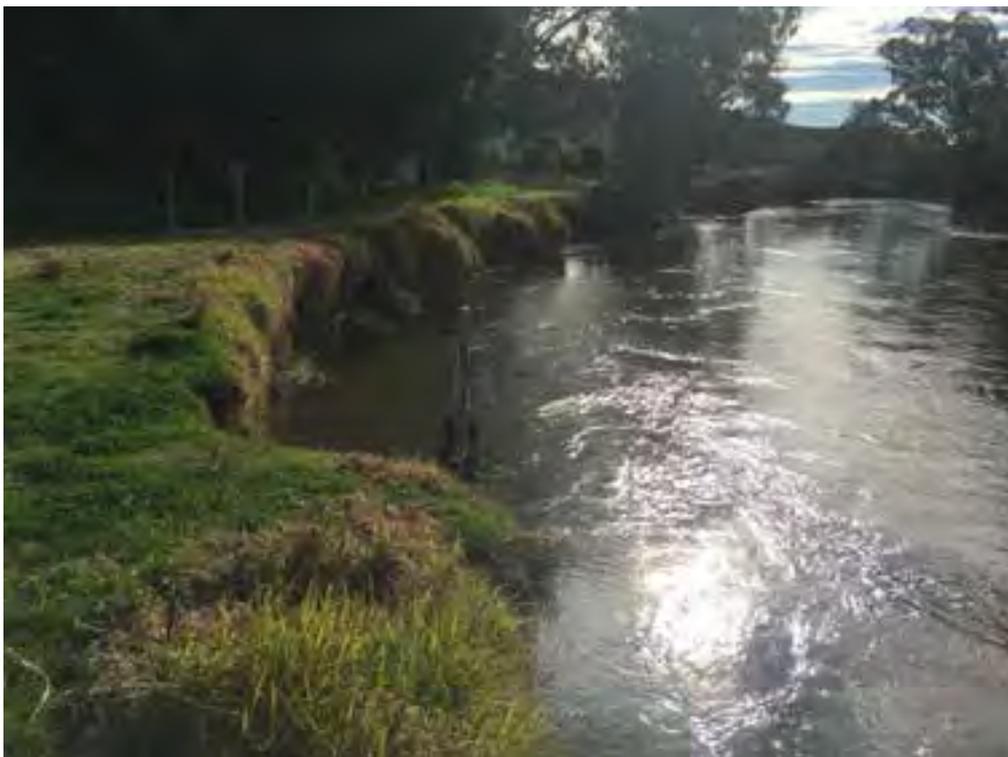
Figure 4-76 Outside bend located downstream of the Murray Valley Highway. Note the absence of riparian vegetation. Bank erosion has occurred across this outside bend.
