## 4 CATCHMENT CONDITION

## 4.2 Kookinburra Creek

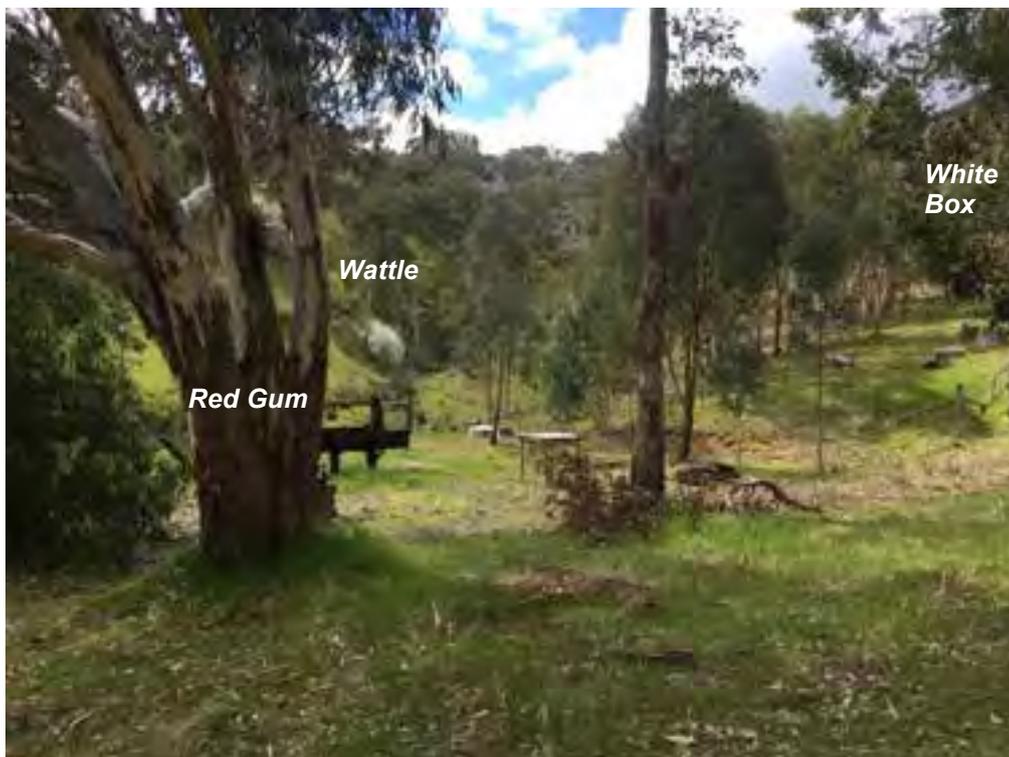
Due to the steep and relatively rocky nature of this reach, many remnant native trees and shrubs remain within the riparian zone (Figure 4-3). The land use in and around the riparian zone is predominantly grazing. The original Ecological Vegetation Class (EVC) is mapped as EVC175 Grassy Woodland (DELWP 2018a) and is described in its EVC benchmark as; “A variable open eucalypt woodland to 15 m tall or occasionally Sheoak woodland to 10 m tall on more skeletal soils. Understorey includes a diverse ground layer of grasses and herbs. The shrub component is usually sparse. It occurs on sites with moderate fertility on gentle slopes or undulating hills on a range of geologies” (DELWP 2018b). The native species observed in this sub-reach are characteristic of this EVC.

Figure 4-3 Vegetation along the upper Kookinburra Creek.

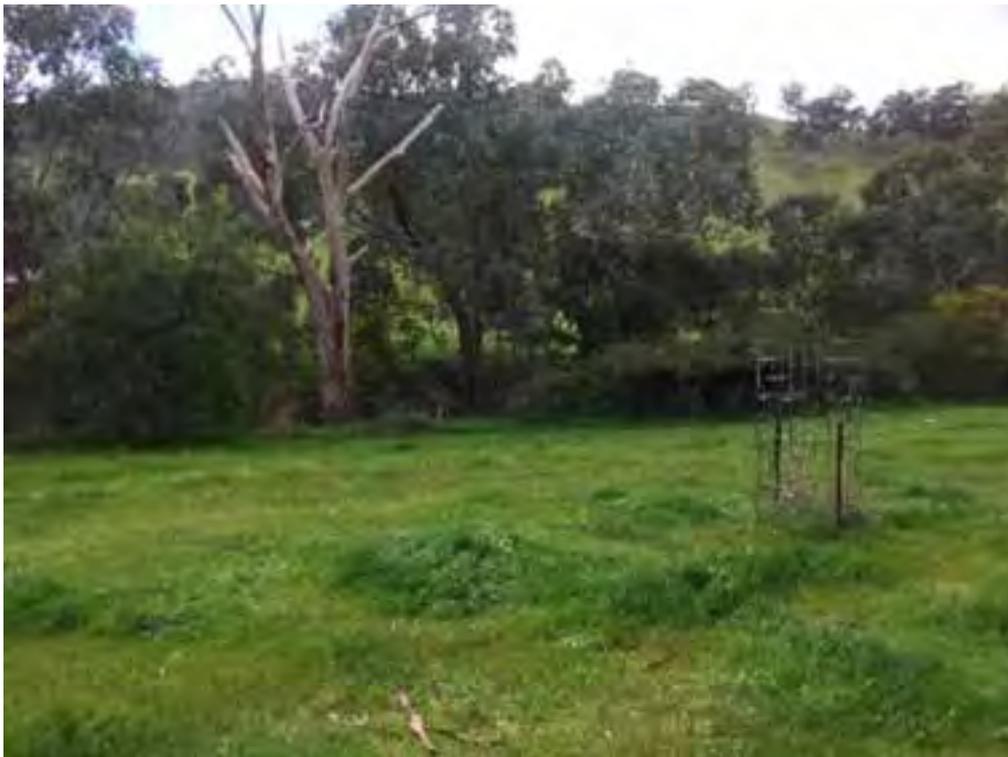
Upstream of the Barnawartha South Bushland Reserve the channel is entrenched, which is likely associated with past bed deepening processes (Figure 4-4). The entrenched section has been fenced and revegetated. Due to access constraints it is not known if the entrenched channel is still subject to active bed deepening or associated bank erosion processes.

Figure 4-4 Entrenched section of Kookinburra Creek which has been fenced and revegetated.

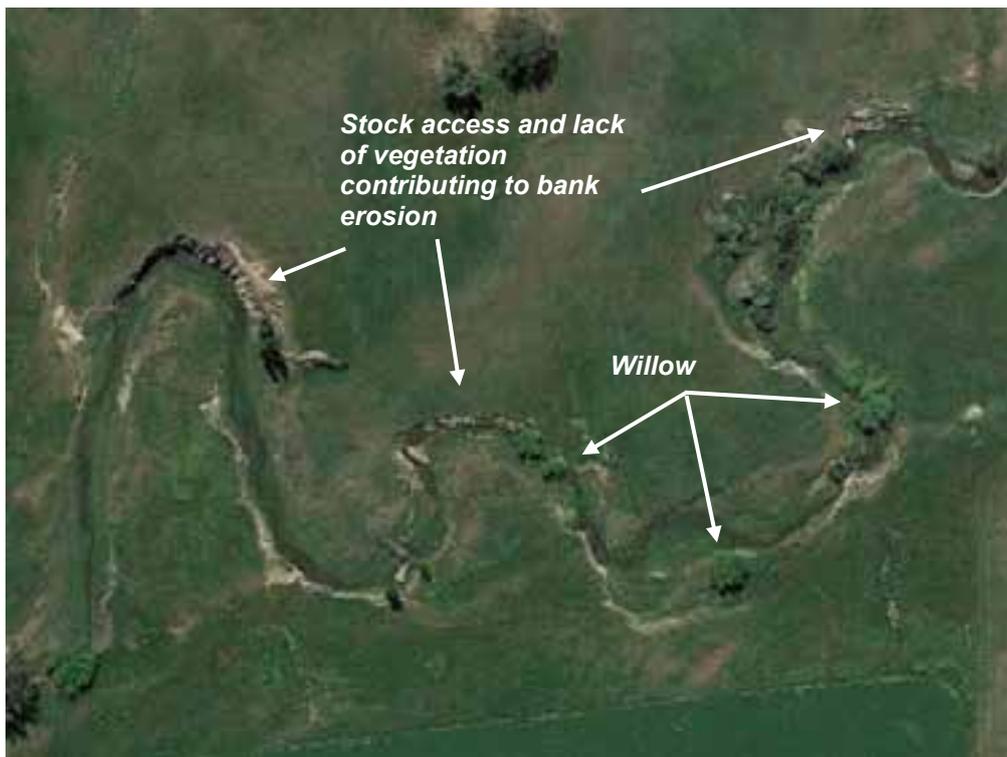
Bank instabilities appear to be more prevalent towards the downstream section of this reach (approximately within two kilometres upstream of Oates Gap Road (Figure 4-5)). The bank erosion appears to be most obvious on outside bends. The erosion is likely exacerbated by an absence of riparian vegetation and unrestricted stock access.

Figure 4-5 Bank instabilities on Kookinburra Creek.

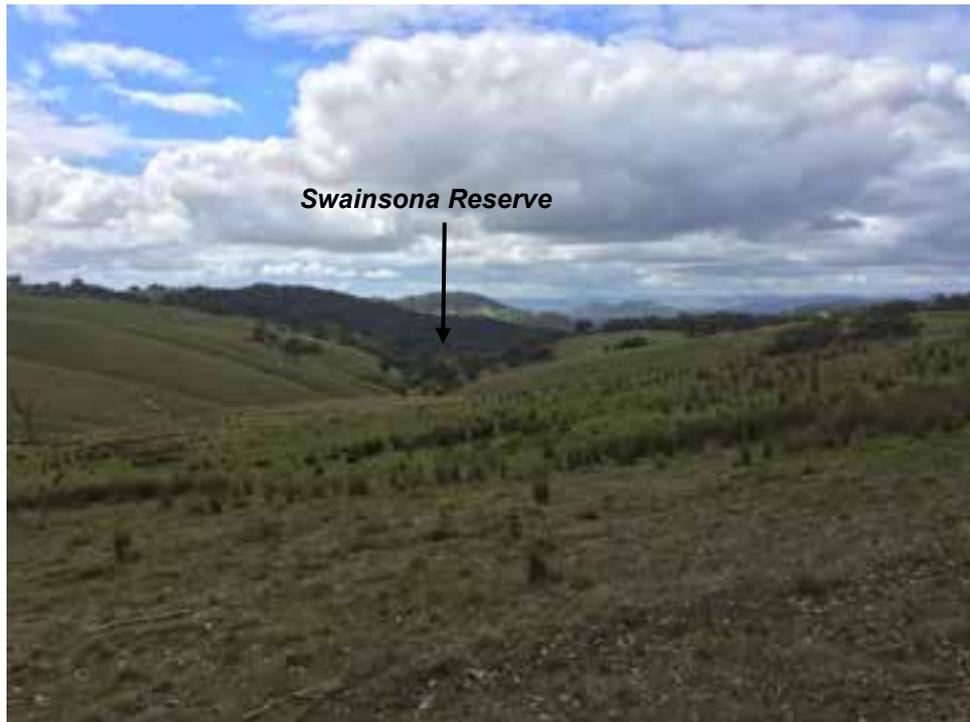
**Figure 4-7** Looking down the Felltimber Creek valley. Note the largely cleared catchment, with the exception of the Swainsona Reserve.

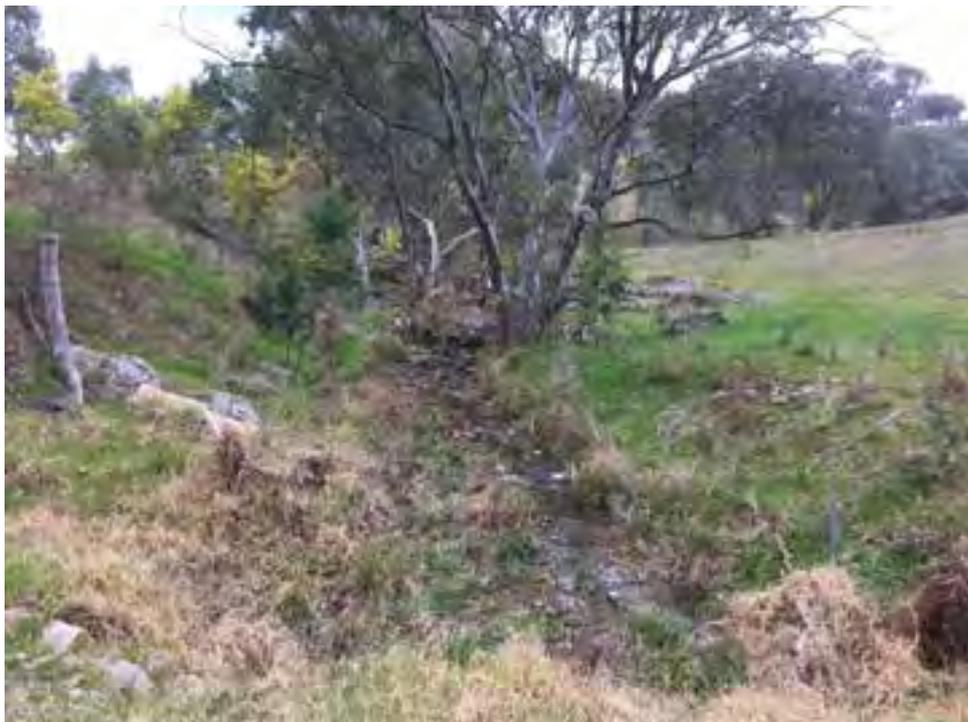
**Figure 4-8** Looking upstream at Upper Reach of Felltimber Creek. The bedrock and floating rock make the reach highly stable.

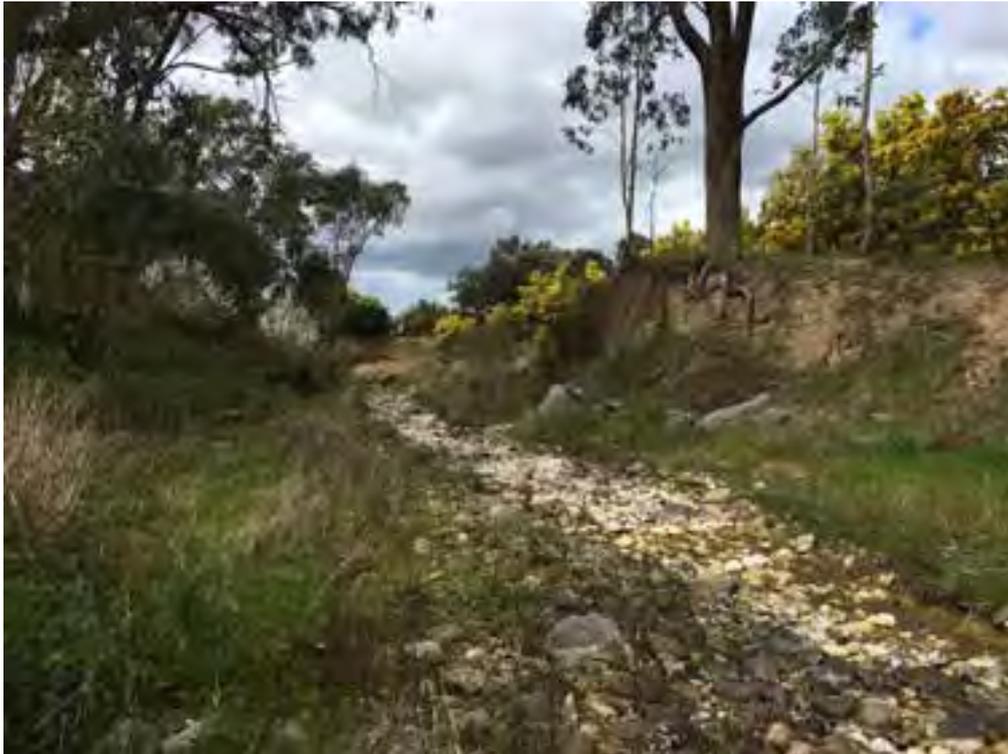
**Figure 4-9** Downstream view of the entrenched section of Felltimber Creek. Inset floodplain pockets have formed in this section and discontinuous bank erosion is evident.

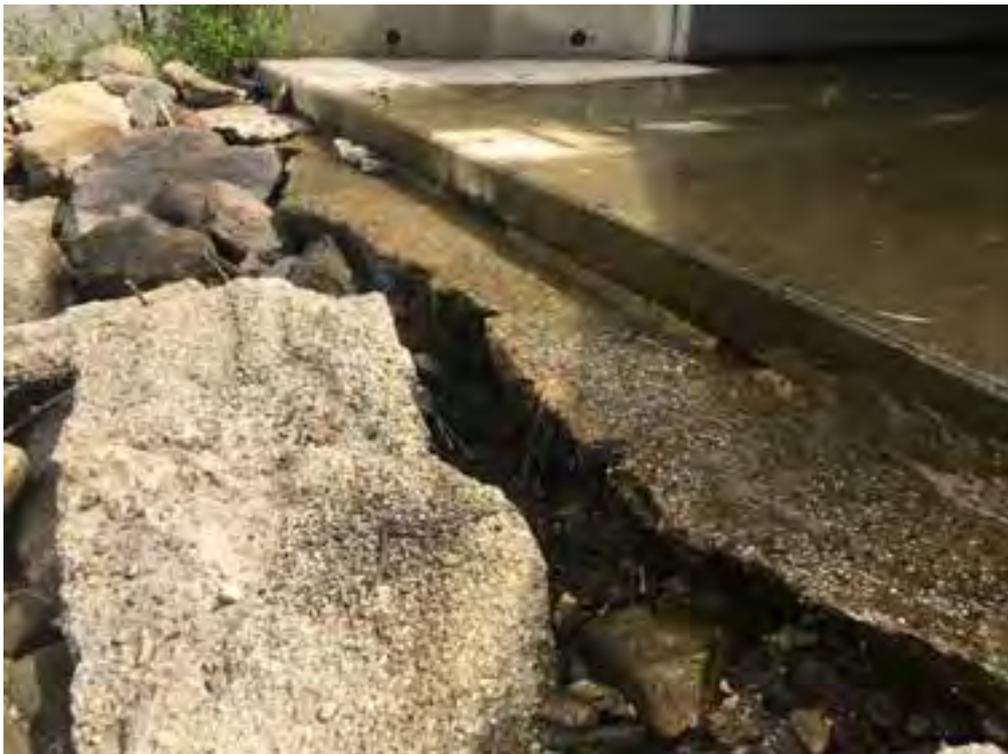
**Figure 4-10** Downstream view of the culvert crossing beneath McGaffins Road. The base of the structure is being to undermine.

- **The structural integrity of culvert crossing over McGaffins Road may be threatened by further scouring at the outlet.**
- **The exotic vegetation progressively increases in a downstream direction within this reach. The woody weeds in combination with English Ivy threaten to outcompete and smother even the larger native woody species.**

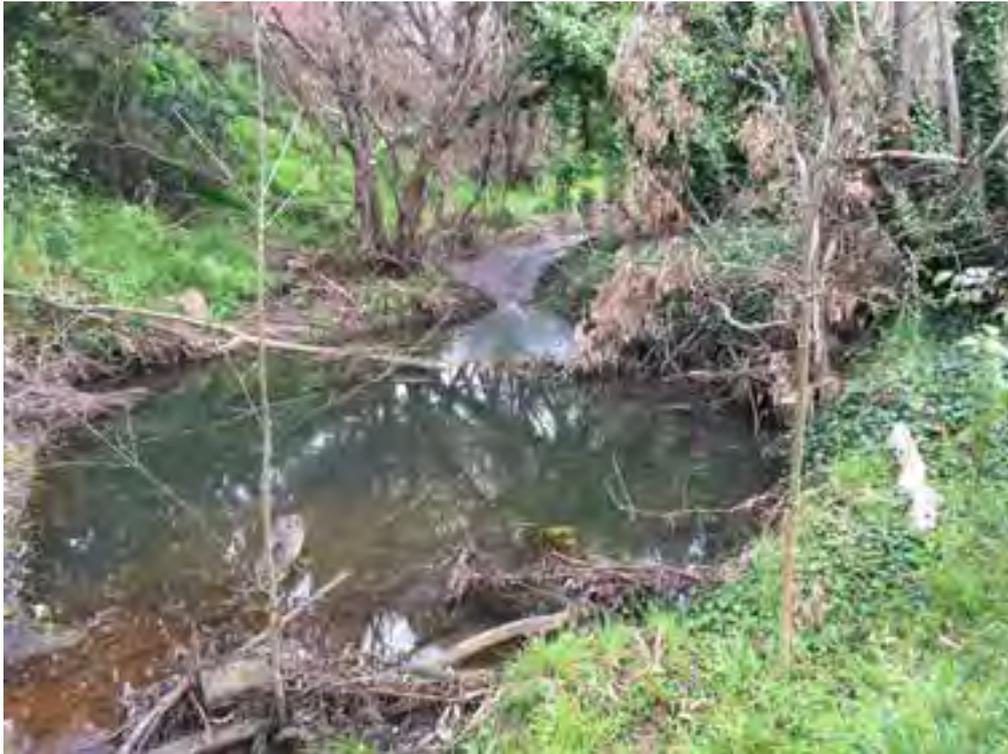
Downstream of Felltimber Creek Road, changes in bed grade are evident within the channel. These changes in bed grade are currently being stabilised by willow roots. In-stream willows are also contributing to the bedform within this reach, through the deposition of sand.

Figure 4-11 Upstream view of a change in bed grade within Felltimber Creek downstream of Felltimber Creek Road, currently held by willow roots.

- **Bed deepening processes are still evident within the section of Felltimber Creek downstream of Felltimber Creek Road. Any structural works undertaken within this reach should aim to manage this process.**

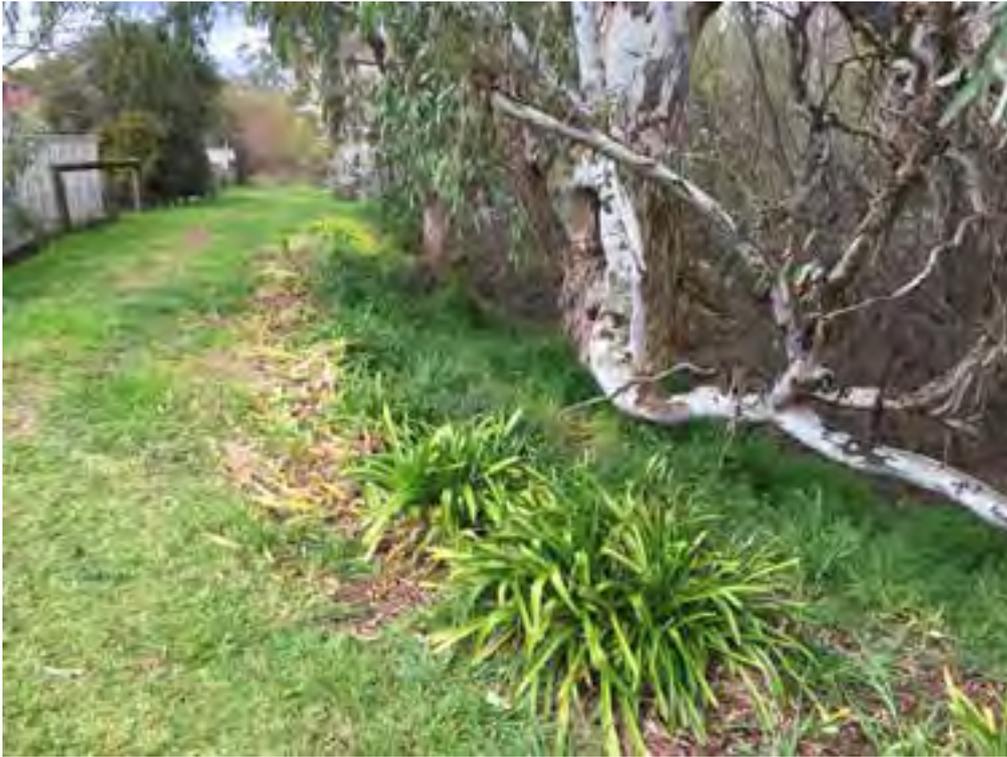
**Figure 4-12** Downstream view of Felltimber Creek downstream of Felltimber Creek Road showing the urban encroachment and garden plantings.

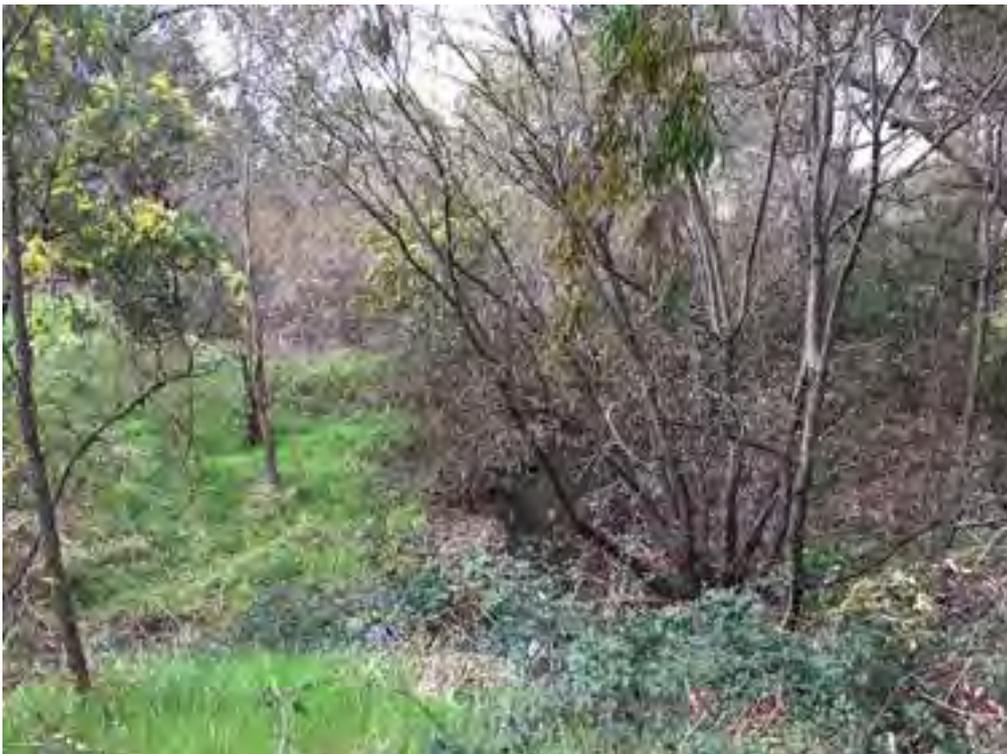
**Figure 4-13** Felltimber Creek Mid Reach weeds become more abundant and diverse in a downstream direction.

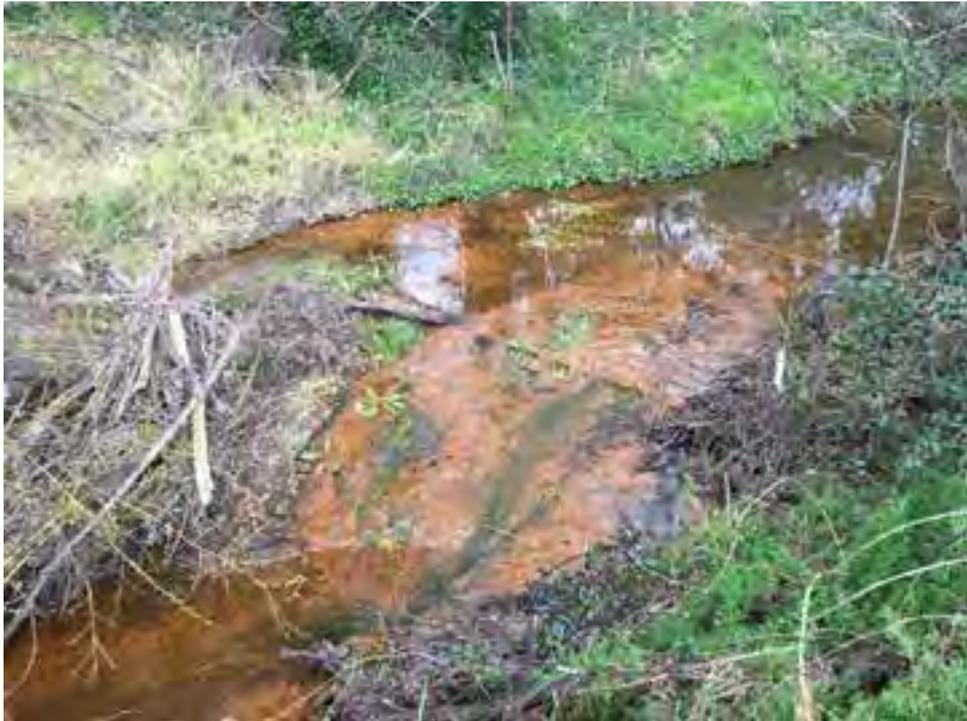
This reach of Felltimber Creek has been subject to active bed deepening processes, evident through the presence of multiple small head-cuts (Figure 4-14). Bank erosion is present in only isolated locations. Woody weeds, primarily willows are contributing to both bed and bank stability within this reach. The creek typically lacks in-stream geomorphic diversity, influenced through the bed deepening processes, in-stream willow presence and absence of in-channel large woody debris.

Figure 4-14 Head-cut present in the Golf Course Reach.

- Active bed deepening processes are evident within the section of Felltimber Creek. Any structural works undertaken within this reach should aim to manage this process. Widespread bank erosion associated with the bed deepening processes is not evident.

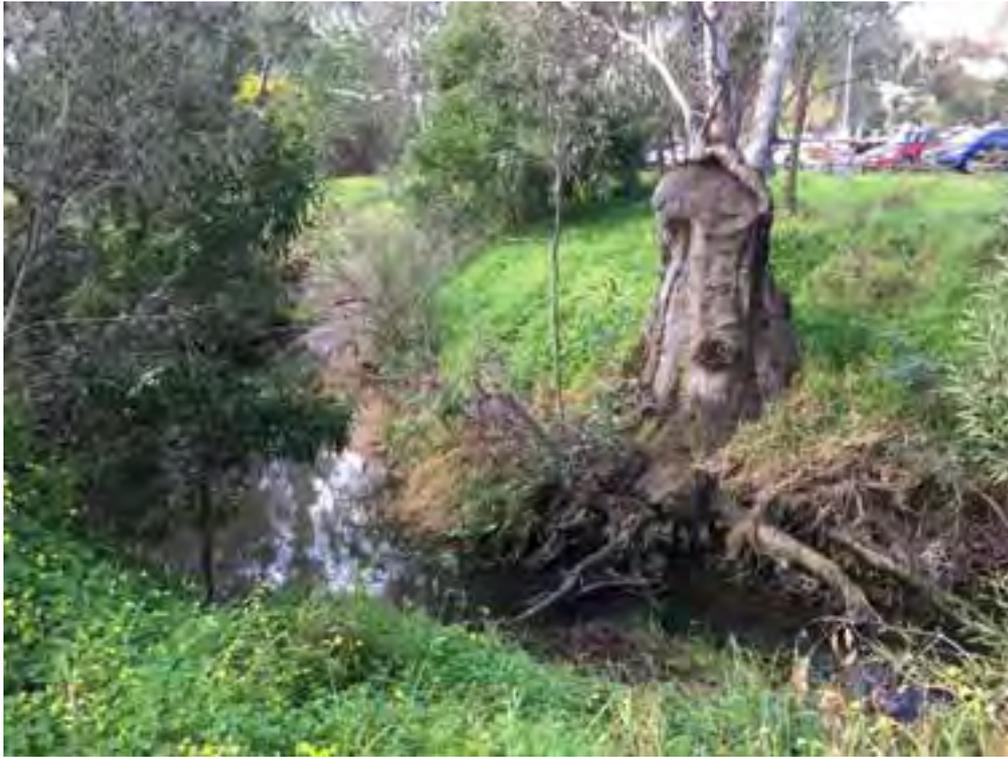
**Figure 4-17** Felltimber Creek has deepened, evidenced by the exposed River Red Gum roots in this image.

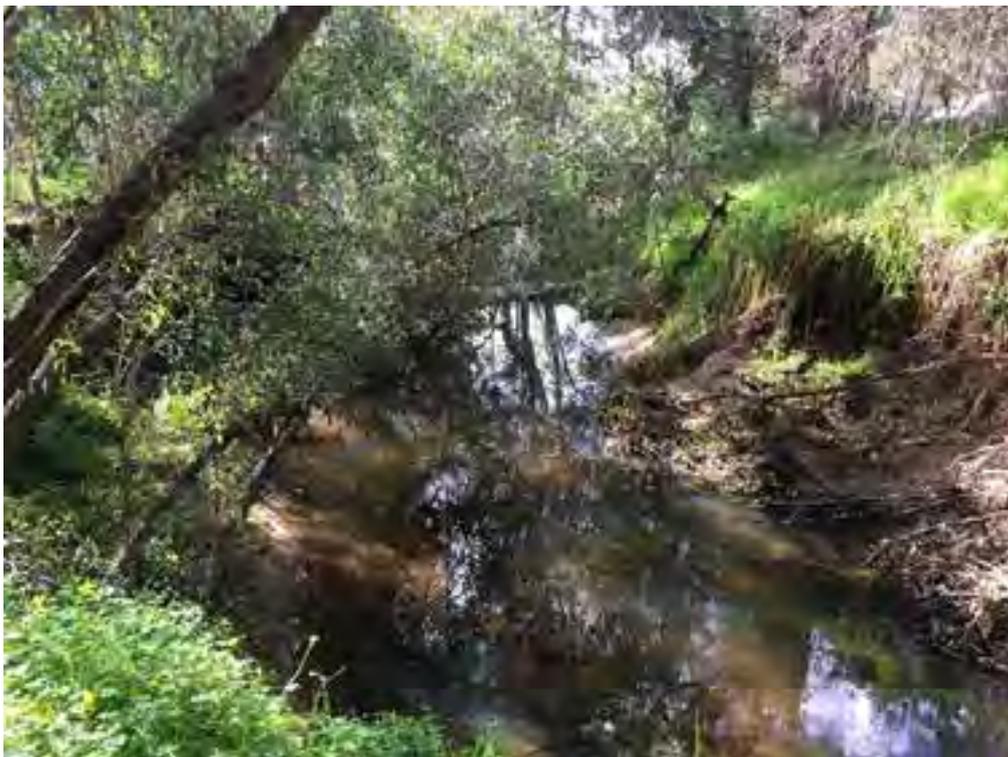
**Figure 4-18** Bank erosion within the Lower Reach of Felltimber Creek.

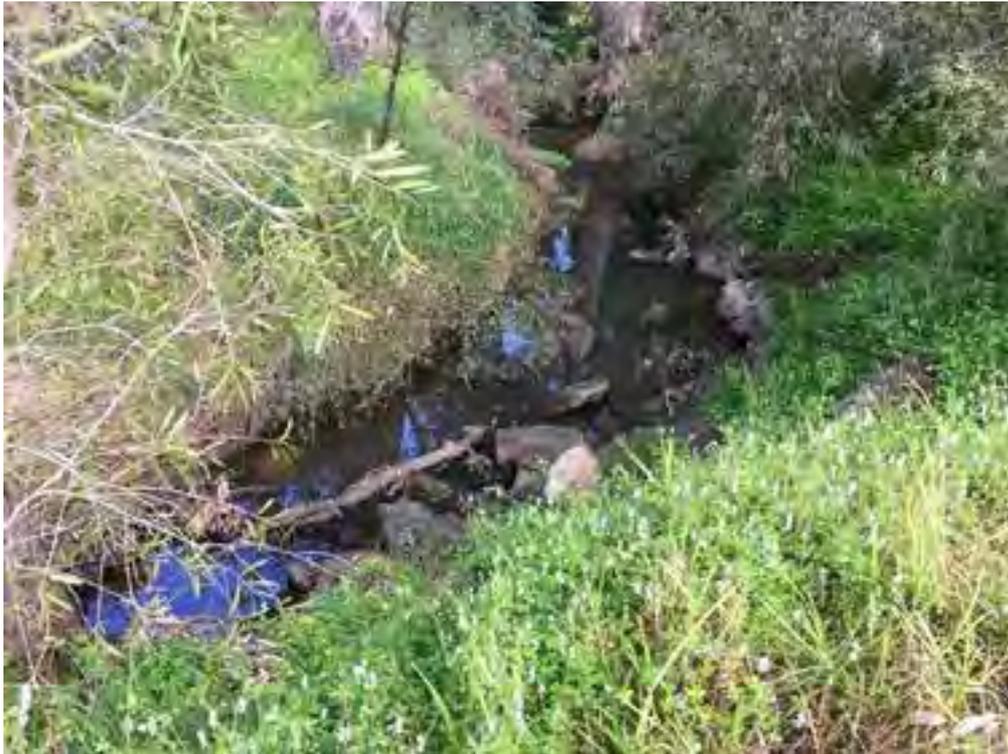
Figure 4-19 Looking upstream at rock beaching work within the lower section of Felltimber Creek, adjacent Wodonga TAFE.

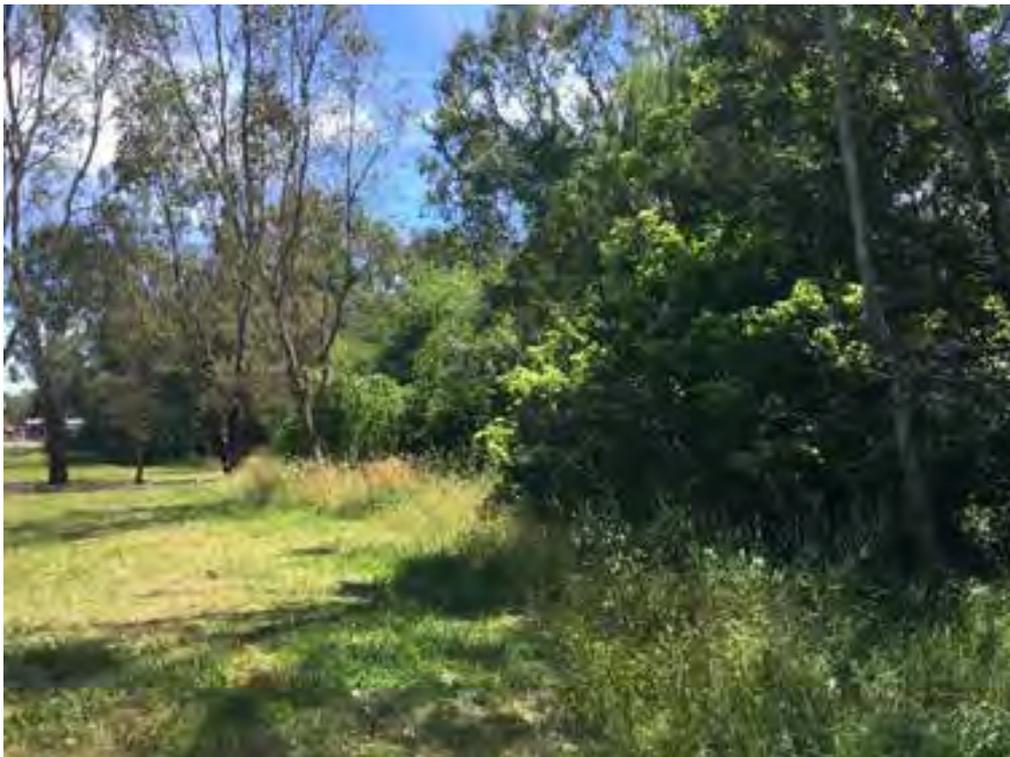
This reach contains an abundance of large Red Gum and Silver Wattle. The upstream section adjacent to Morefield Park Drive (Figure 4-20) has continuous broad woody vegetation cover surrounding the creek. There is also an abundance of woody tree weeds including Weeping Willow, Box Elder and Desert Ash.

**Figure 4-20** Felltimber Creek adjacent to Morefield Park Drive showing the woody riparian vegetation comprises a mixture of native and exotic species.

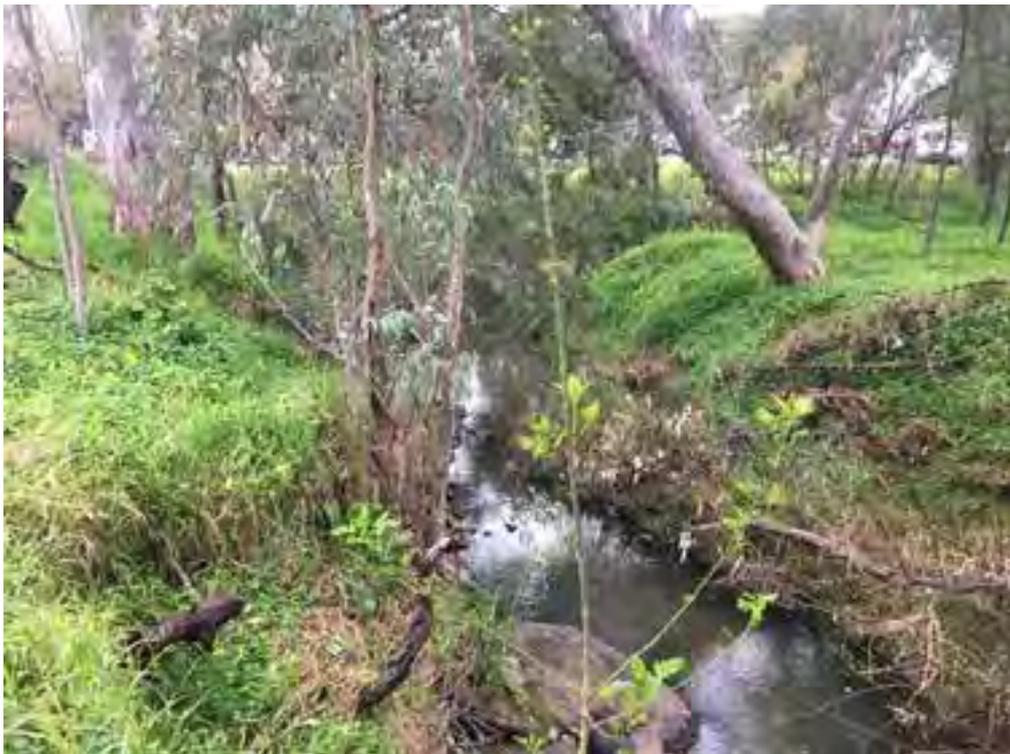
The downstream section adjacent to the TAFE has had extensive levels of weed control, yet despite this effort, woody weeds, mostly Ash, are continuing to invade closer to the freeway. The tree canopy is taller and denser compared to the upstream reaches and the ground layer is dominated by exotic Kikuyu and Soursob (Figure 4-21).

**Figure 4-21** Felltimber Creek adjacent Wodonga TAFE showing exotic groundcover.

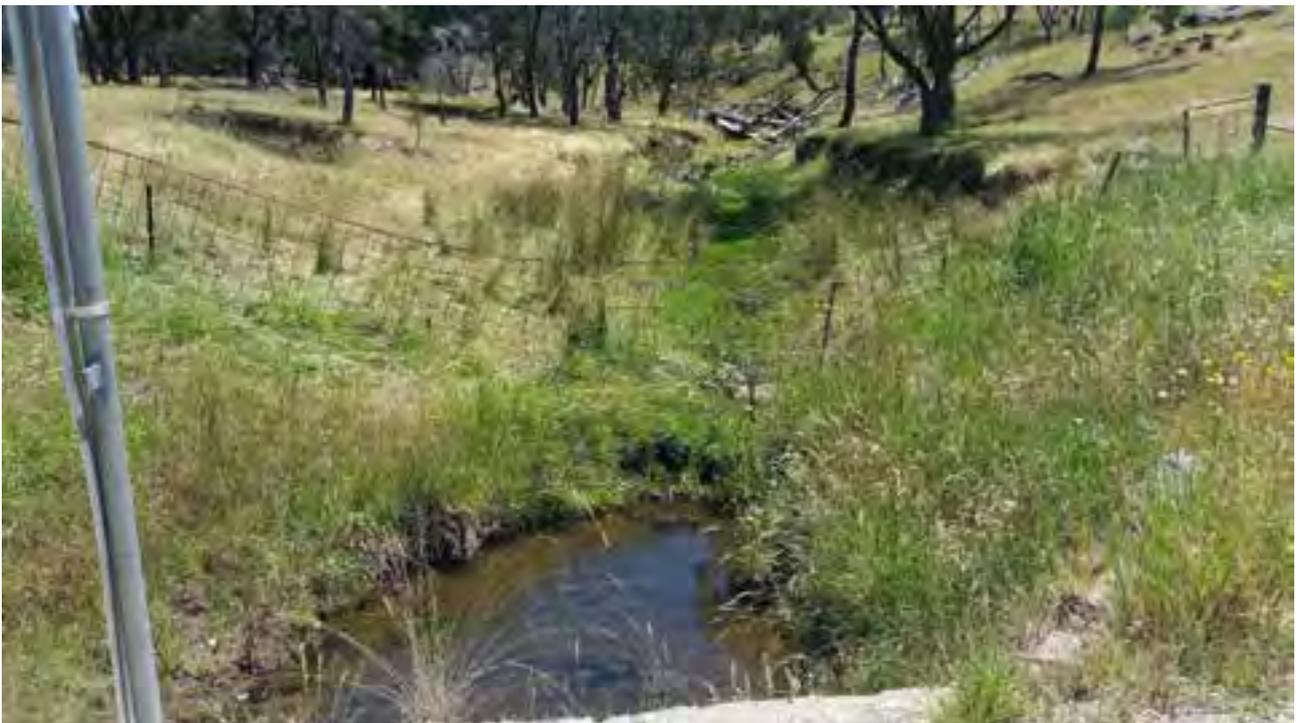
**Figure 4-24** A small head-cut located upstream of the Gilbert Road crossing.

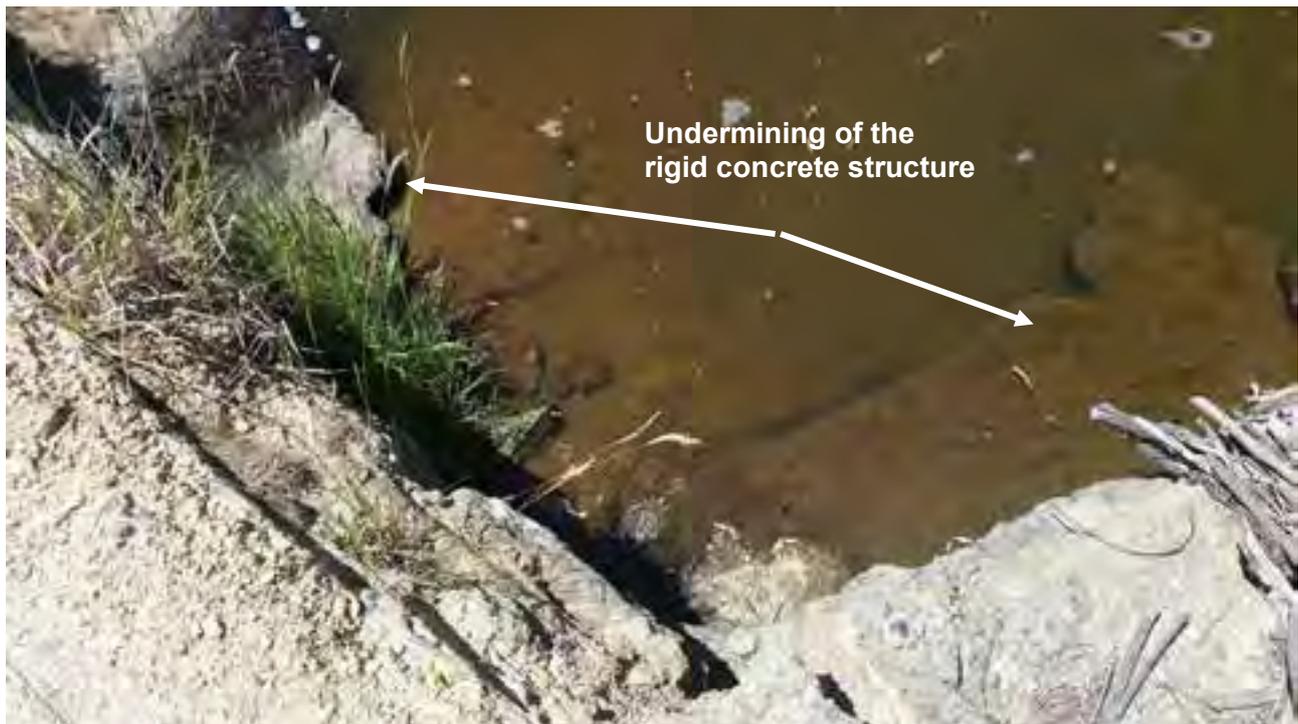
Scouring has occurred on the downstream side of the crossing at Gilbert Road (Figure 4-25). The scouring has likely developed due to high exit velocities through the culvert, cascading flows when the crossing is being over topped and a lack of rock armouring of the channel bed and bank around the crossing. The scouring has led to undermining which has the potential to impact upon the integrity of the crossing.

Figure 4-25 Undermining of the Gilberts Road crossing.

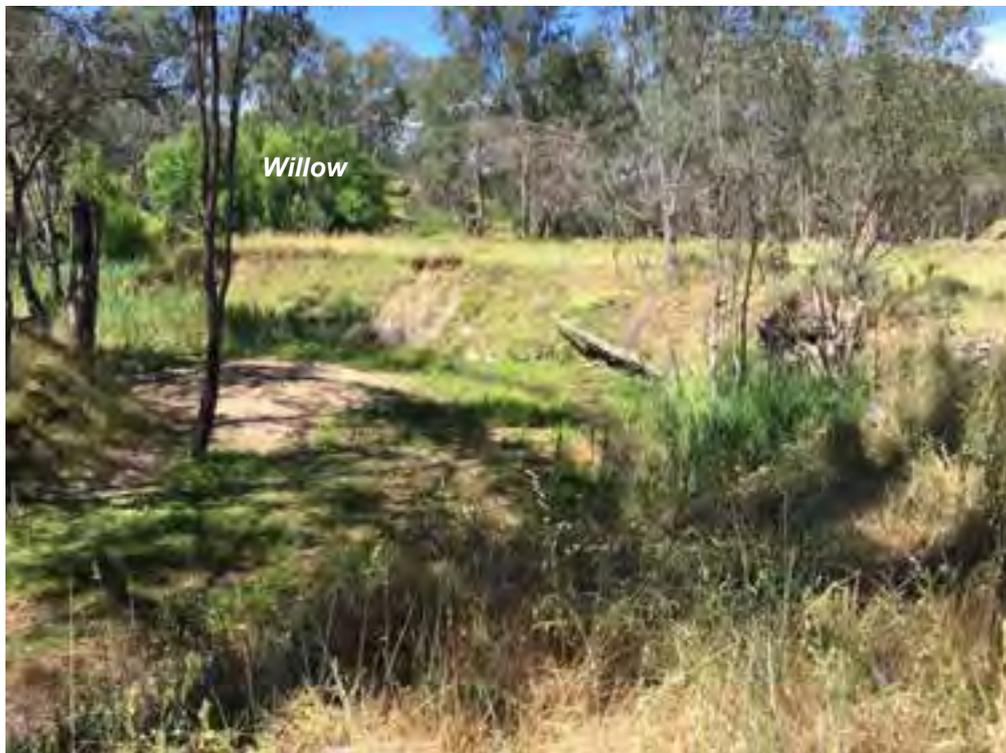
Figure 4-26 Over enlarged channel located within the Mid Reach of Huon Creek.

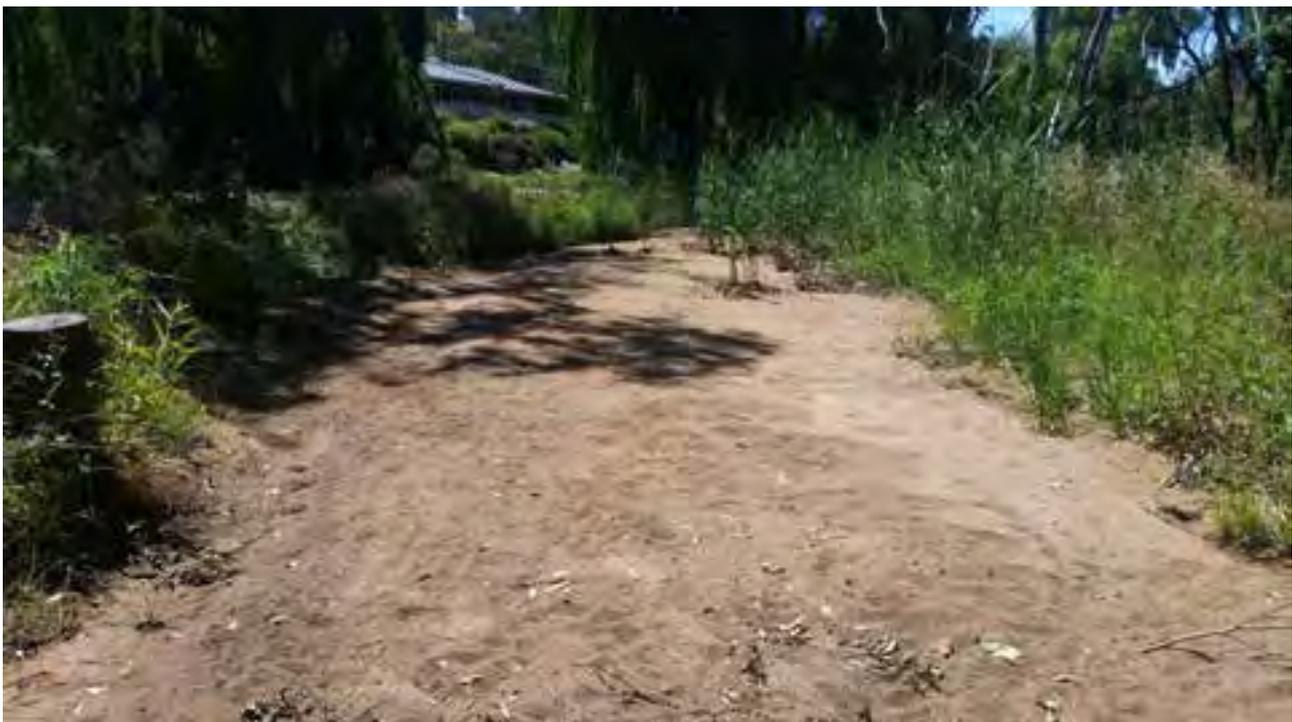
The dominant geomorphic process occurring in the Lower Reach of Huon Creek is aggradation as a result of erosion in the upper catchment. The oversupply of sand has resulted in the raising of the bed level and a loss of geomorphic variability (Figure 4-28) with a uniform bed profile present across most of the reach. Some of the sand is being transported further downstream as evident by the sand splay in House Creek at the confluence of Huon Creek (Figure 4-29). Only isolated bank instabilities were observed in this reach.

Figure 4-28 Deposited sand creating a uniform bed profile in the Lower Reach of Huon Creek.

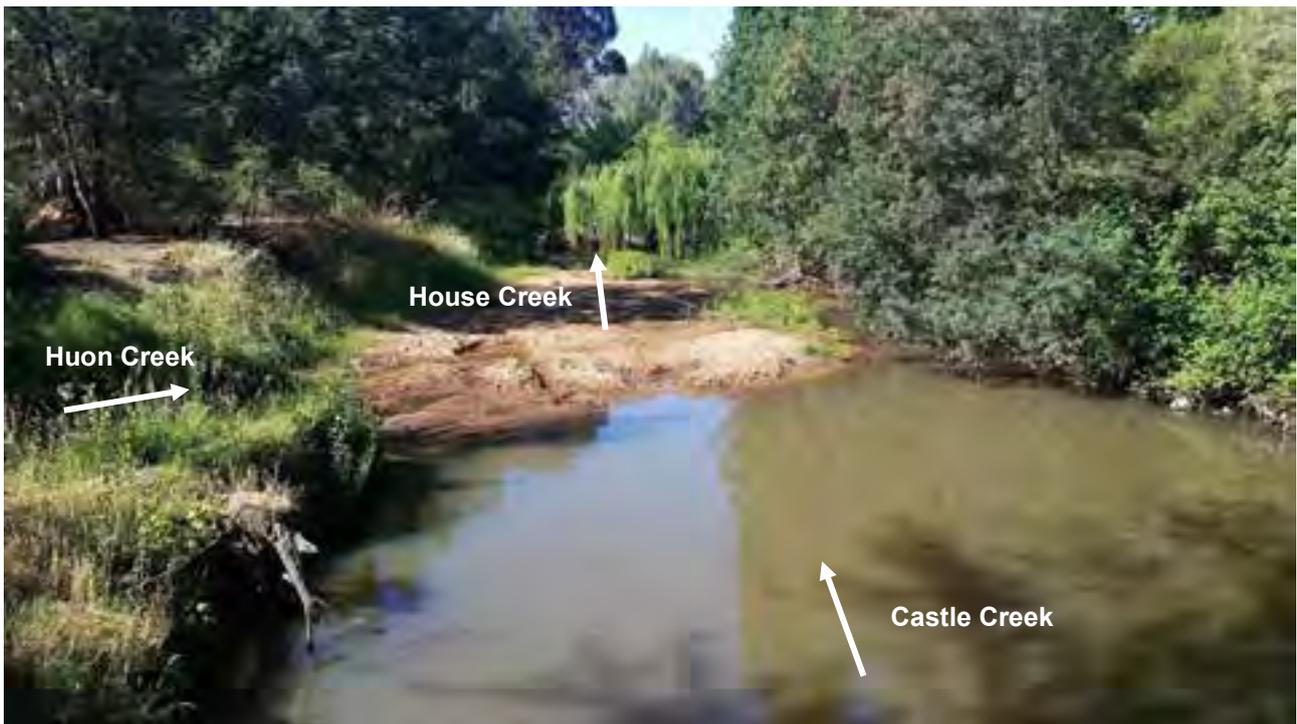
Figure 4-29 Sand being transported through Huon Creek and being deposited in House Creek.

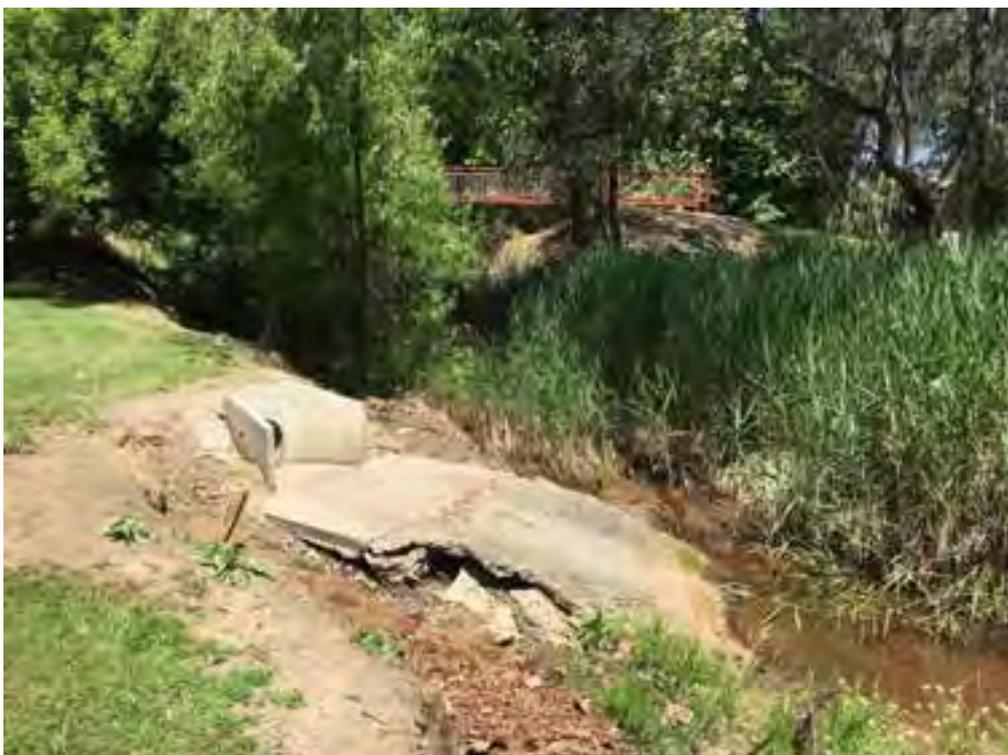
Erosion surrounding a concrete apron on stormwater outfall was observed on the right bank downstream of footbridge at Veronica Egan Park (Figure 4-30). The concrete apron has cracked and is undermined.

Figure 4-30 Looking upstream at erosion around a stormwater outlet on Huon Creek at Veronica Egan Park.

- The structural integrity of the stormwater outlet at Veronica Egan Park is threatened. Without intervention, the structure is expected to fail in the short to medium term, which will lead to further bank erosion.

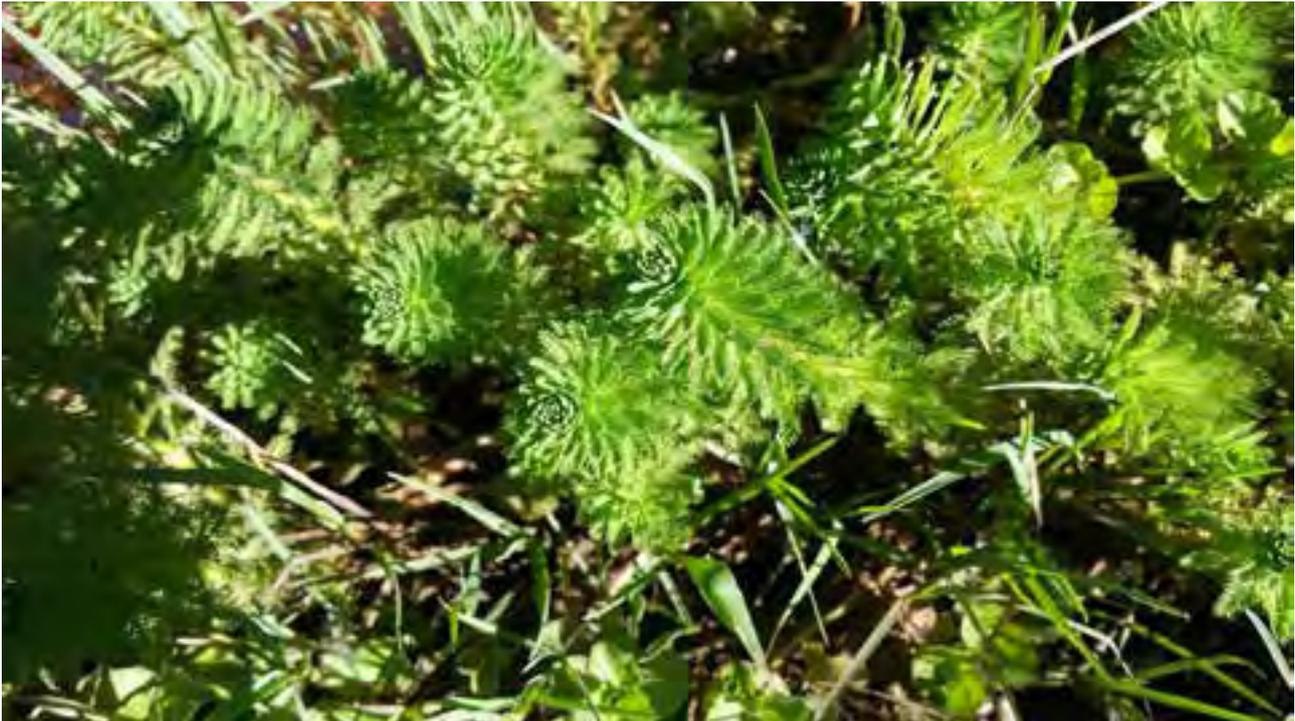
The invasive perennial aquatic weed, Parrot's Feather (*Myriophyllum aquaticum*) was observed in a small patch (3m<sup>2</sup>), approximately 10m upstream from the Castle Creek confluence. One other infestation was observed mid-way down House Creek. This plant forms dense stands that can impede water and cause entanglement. Parrot's Feather spreads by stem fragments (seed is not produced in Australia (Sainty & Jacobs 2003)). A more thorough survey of the lower end of Huon Creek and the entire House Creek should be undertaken to identify infestations and an eradication program implemented while infestation levels are low.

Figure 4-32 Close up view of Parrot's Feather at the downstream end of Huon Creek.

- The aquatic weed Parrot's Feather, located at the bottom end of Huon Creek has the potential spread downstream into House Creek from detached fragments. One other infestation was observed mid-way down House Creek. Eradication of this plant from Huon Creek should be a priority to ensure downstream propagation does not occur.

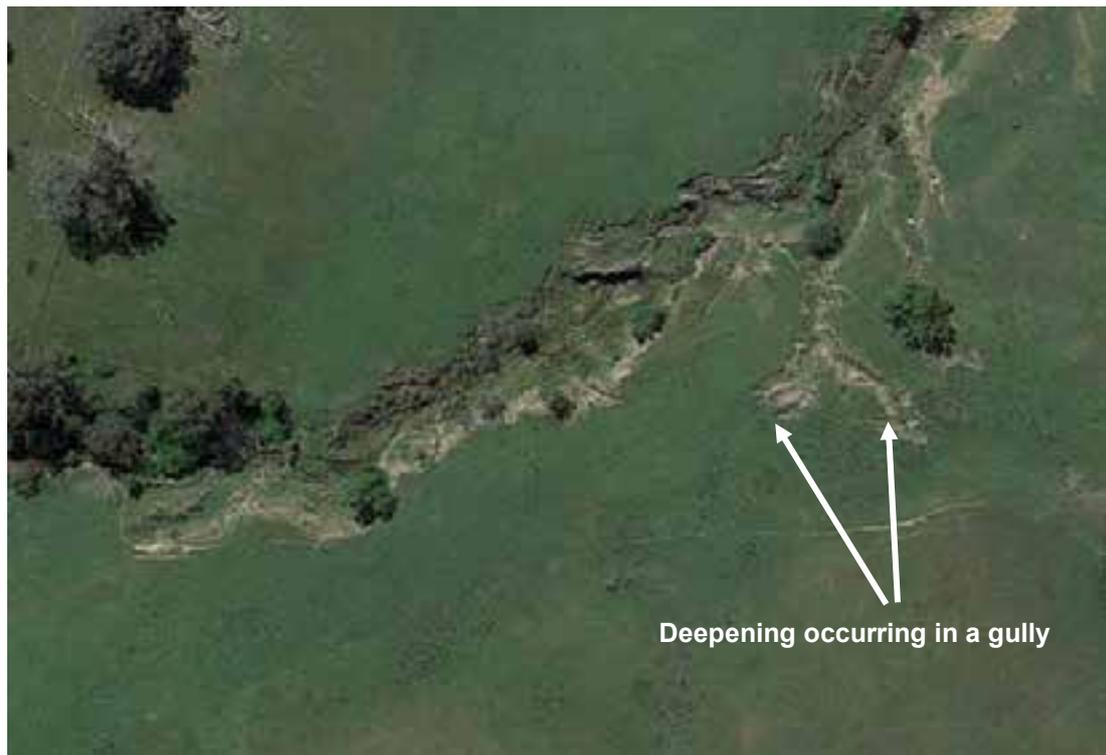
Figure 4-36 The bank damage and erosion caused by cattle and gully erosion in the Upper Reach of Castle Creek.

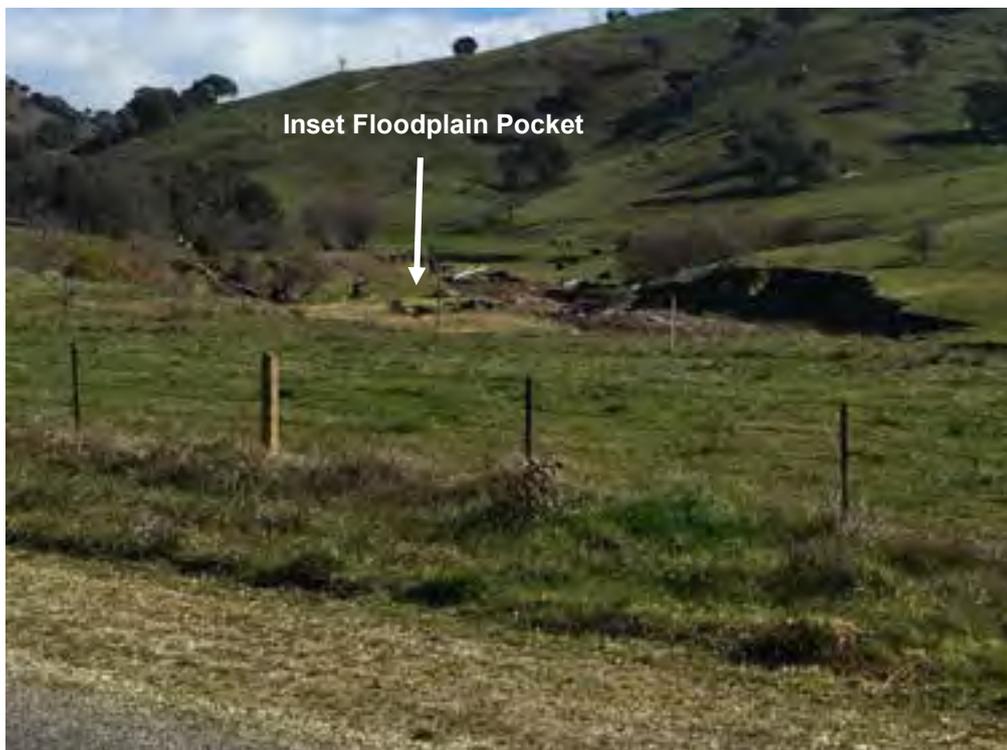
Figure 4-37 Looking upstream at an over enlarged section of Castle Creek with an inset floodplain pocket.

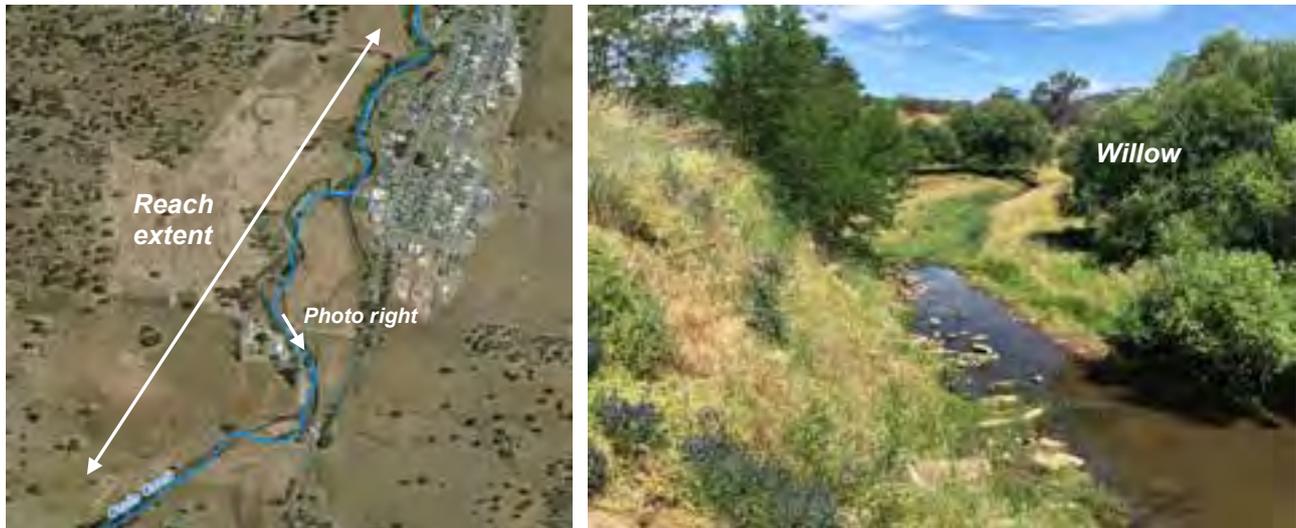
There are very few native canopy trees remaining adjacent to the current widened creek channel. Remnant riparian trees were either cleared from the floodplain or have previously fallen into the creek as the channel has eroded and laterally migrated across the floodplain. Native shrubs are virtually absent, and willows are the dominant woody weeds within the reach (Figure 4-38).

Figure 4-38 Reach location and photo showing lack of natives and presence of willows.

- This reach has a declining vegetation condition trajectory as there is very scarce native vegetation cover and willows are likely to continue spreading if left uncontrolled. This reach requires stock grazing management, weed control and revegetation to help stabilise the banks and restore stream health and habitat.
