## 4 CATCHMENT CONDITION

## 4.2 Kookinburra Creek

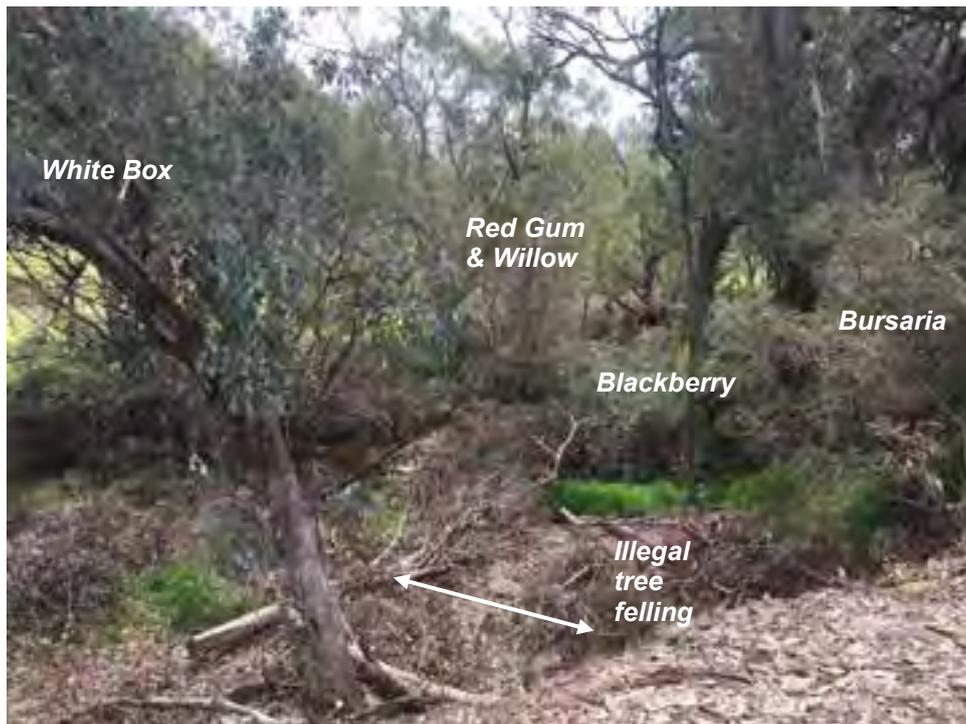
The original native riparian vegetation within this reach is likely to have been EVC68 Creepline Grassy Woodland. The characteristic Red Gum, including remnant River Red Gums and Silver Wattle are still present, however some of this vegetation, for example the remnant River Red Gums within Albert Terrill Reserve, are in very poor health. The native riparian corridor is mixed with a range of exotic weeds and garden escapes dominated by willow and blackberry (Figure 4-15). Observations within this reach included:

- The presence of an ibis rookery towards the downstream end of the reach, adjacent to the end of Lawrence Street.
- Tree felling within the riparian zone at the southern end of Golfinks Avenue.
- Selective woody weed removal that did not include the mature parent tree (seed source).

Figure 4-15 Typical section of the Felltimber Creek reserve, situated between residential development and golf course.

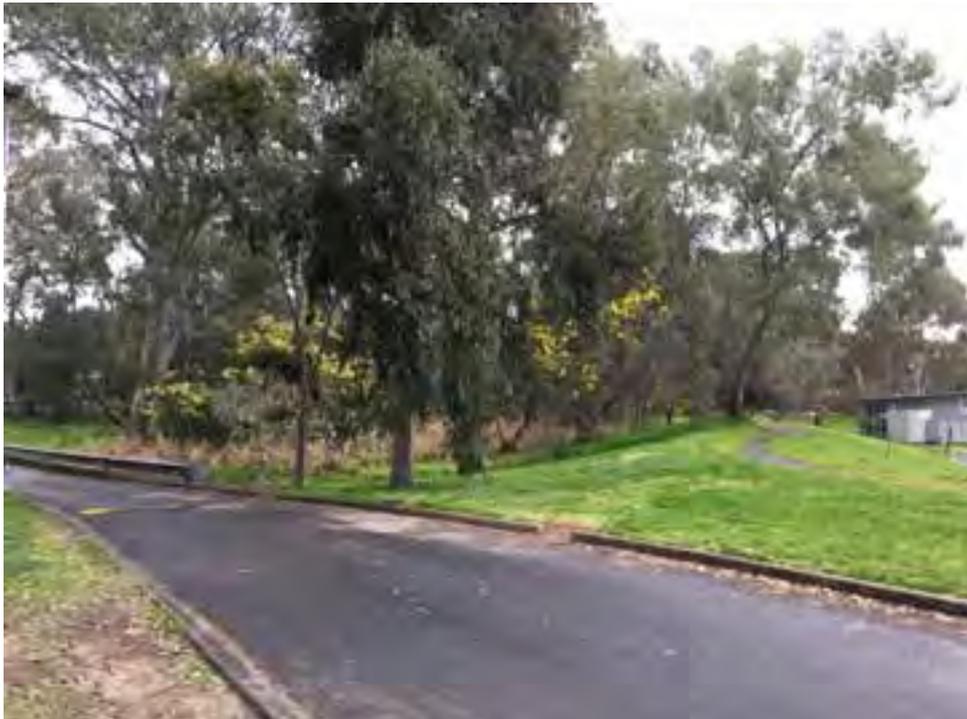
The Lower Reach of Felltimber Creek can be broadly defined as partly confined system, surrounded by typical urban development features and infrastructure including shared paths, car parks, multiple road crossings and a levy on the eastern bank adjacent Wodonga TAFE (Figure 4-16). Additionally, a stormwater treatment wetland is present in Moorefield Park on the western side of the creek.

**Figure 4-16** Looking downstream at the levy along the right bank at Wodonga TAFE.

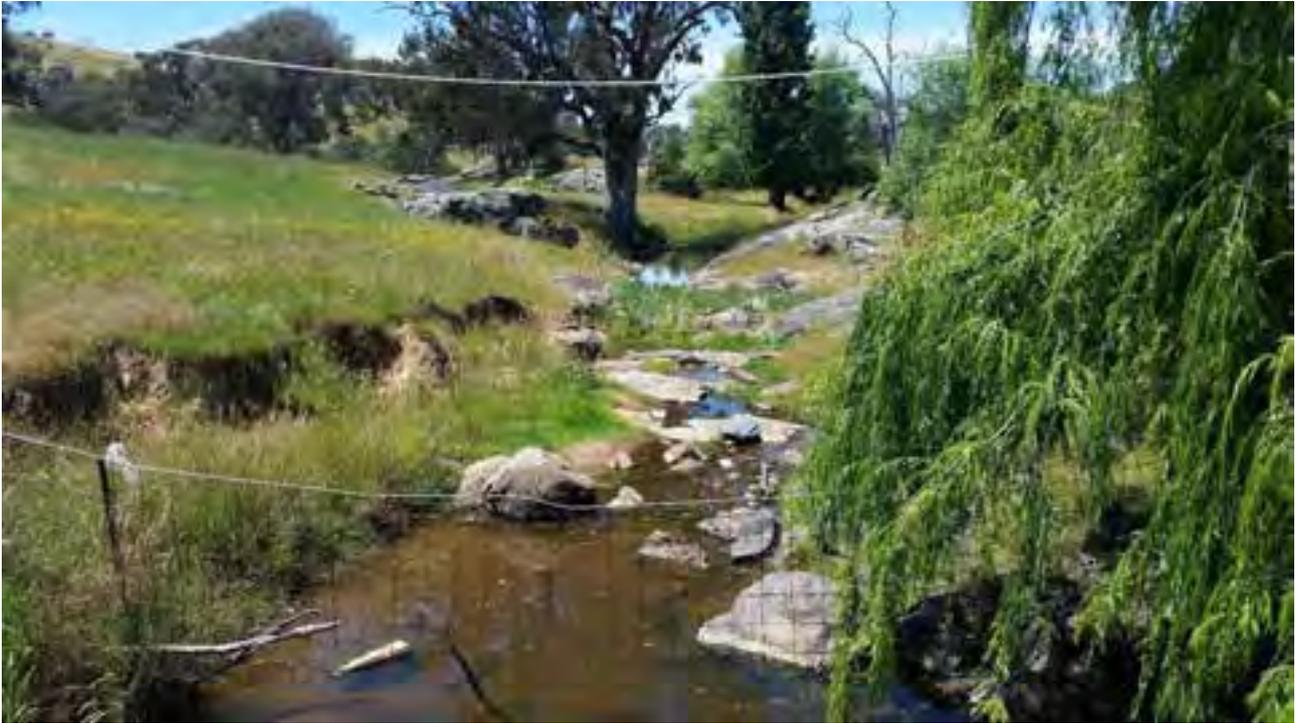
The catchment of the Upper Reach consists of steep cleared hill slopes that are used for grazing. The upper reach of Huon Creek is located within a confined valley, comprising occasional bedrock outcrops which controls the lateral and vertical adjustment of the channel (Figure 4-23). This reach is an ephemeral stream with a steep longitudinal gradient. Despite the occasional bedrock controls, discontinuous deepening is present within this reach (Figure 4-24).

**Figure 4-23** Exposed bedrock located downstream of Gilberts Road.

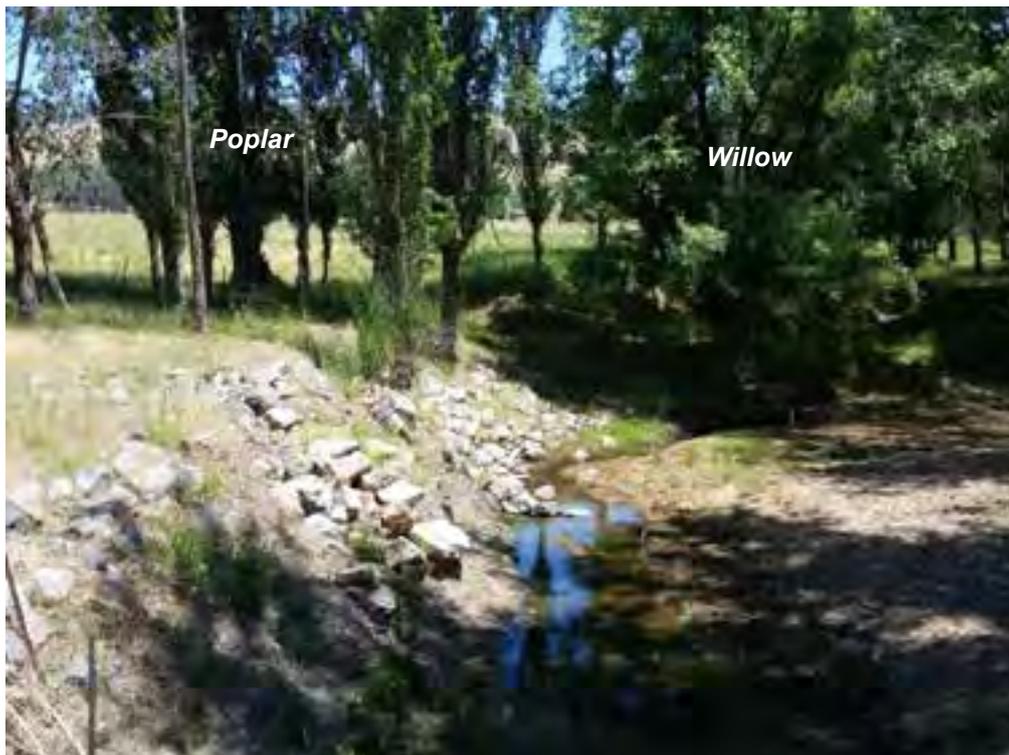
The Mid Reach of Huon Creek has been subject to historic bed deepening processes and associated channel widening. Subsequently, the creek channel is over-enlarged (Figure 4-26). Bank erosion is commonly positioned on outside bends with deposition occurring on the opposite inside bend. Erosion on outside bends is typically associated with meander development and is exacerbated where there is a lack of vegetation. This erosion process can occur in conjunction with, or independently of, the bed deepening processes. Some outside bends within this reach have been armoured with rock to prevent further erosion and meander development (Figure 4-27).

Figure 4-27 Rock beaching located on an outside bend.

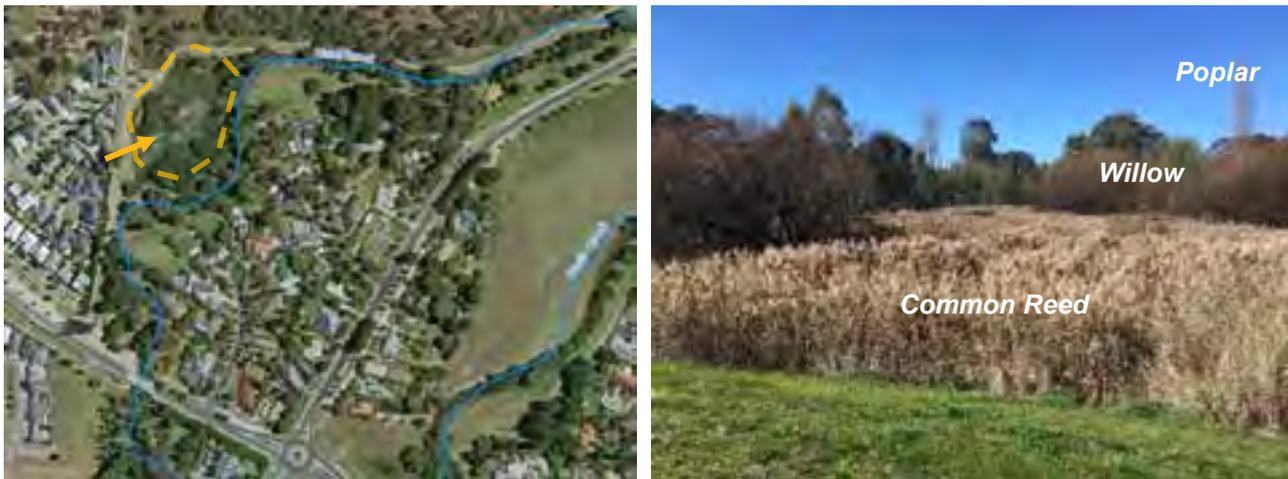
There has been considerable landscaping work and weed management downstream of Yarralumla Drive, within David Winterbottom Park and David Bayne Park. However, large infestations of Willow remain along with a range of other woody species including Poplar and Box Elder. There is a large patch of native Common Reed that has colonised a low-lying area of the floodplain off the left bank of Huon Creek (Figure 4-31). This feature provides a unique habitat in the middle of the urban area, however is viewed by some residents as an issue.

Figure 4-31 Location and photograph of Common Reed wetland.

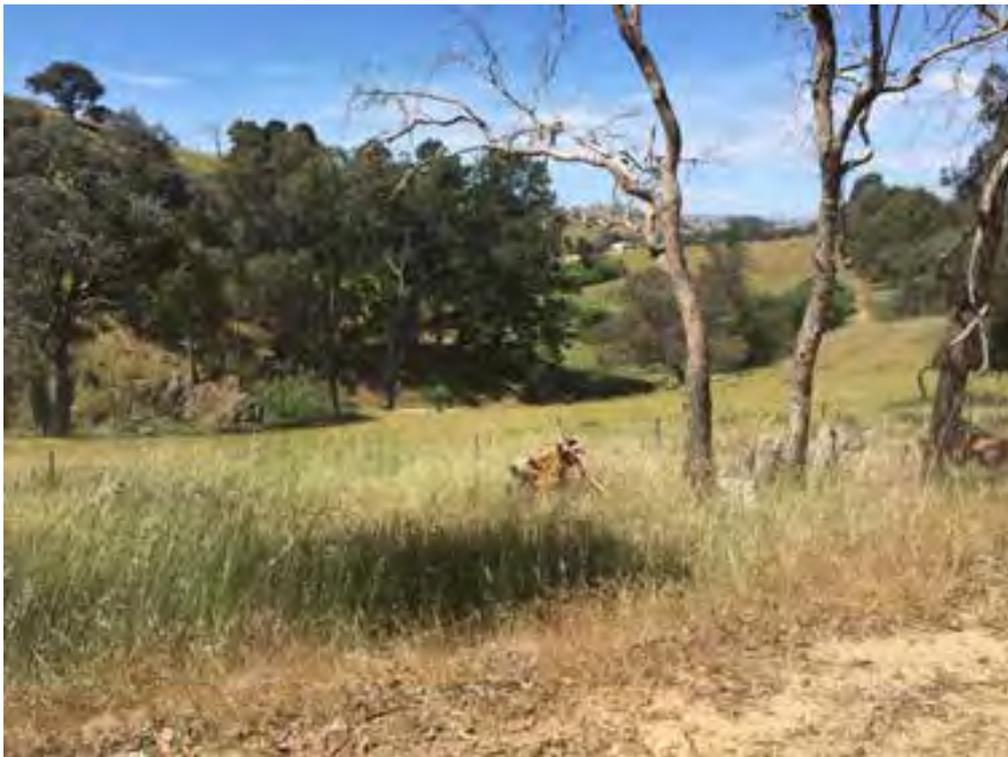
The Upper Reach of Castle Creek has a steep catchment that has been cleared for grazing. The creek has a steep longitudinal gradient and is generally confined by the surrounding hillslope (Figure 4-34). The channel is likely to be subject to discontinuous bed deepening that will be limited by bedrock impingements (Figure 4-35).

**Figure 4-34** Confined Valley of the Upper Reach of Castle Creek.

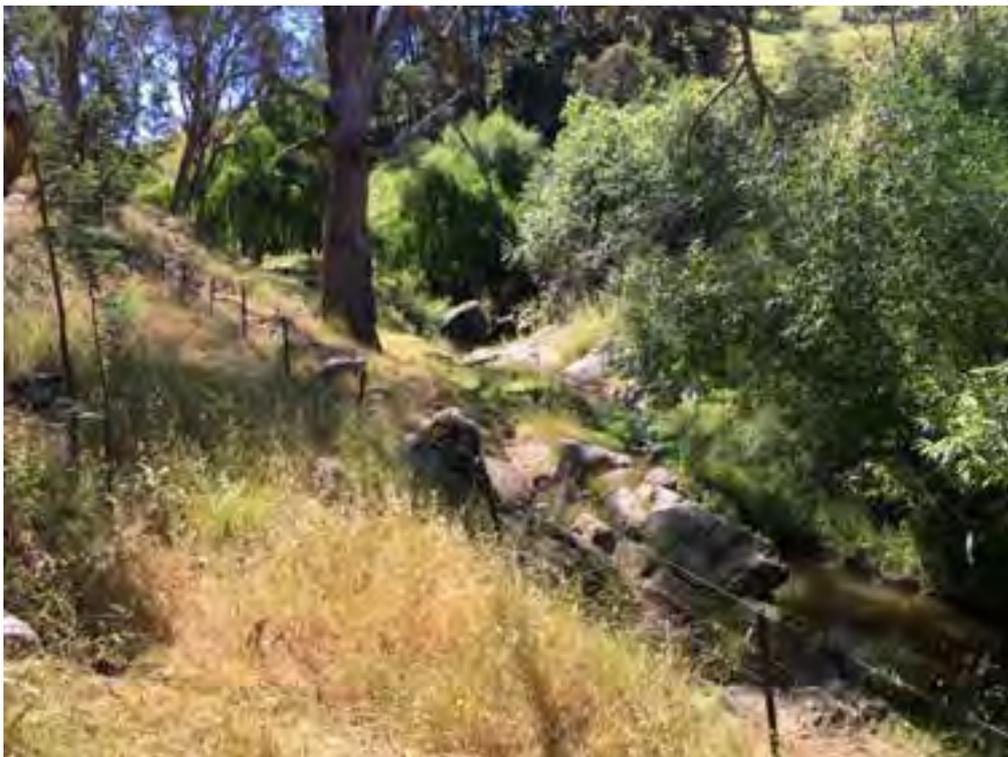
**Figure 4-35** Bedrock steps that are present the Upper Reach of Castle Creek will limit channel adjustment.
