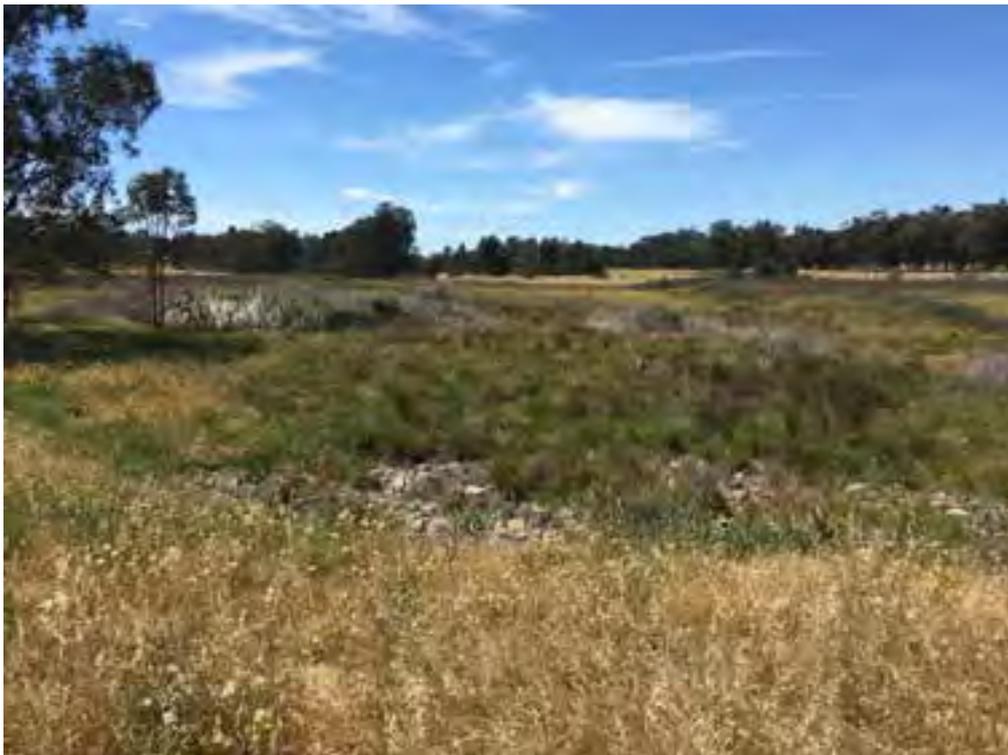
The catchment of the White Box Rise Reach of Jack-in-the-Box Creek includes the steep slopes of Bears Hill, the Bandiana Army Barracks and White Box Rise. A number of small tributaries converge around the corner of Victoria Cross Parade and Chapple Street to form Jack-in-the-Box Creek. The primary channel is an open swale that flows through the eastern side of the Army Barracks (Figure 4-52).

Figure 4-52 Grassed swale that is one of the main tributaries of Jack-in-the-Box Creek.

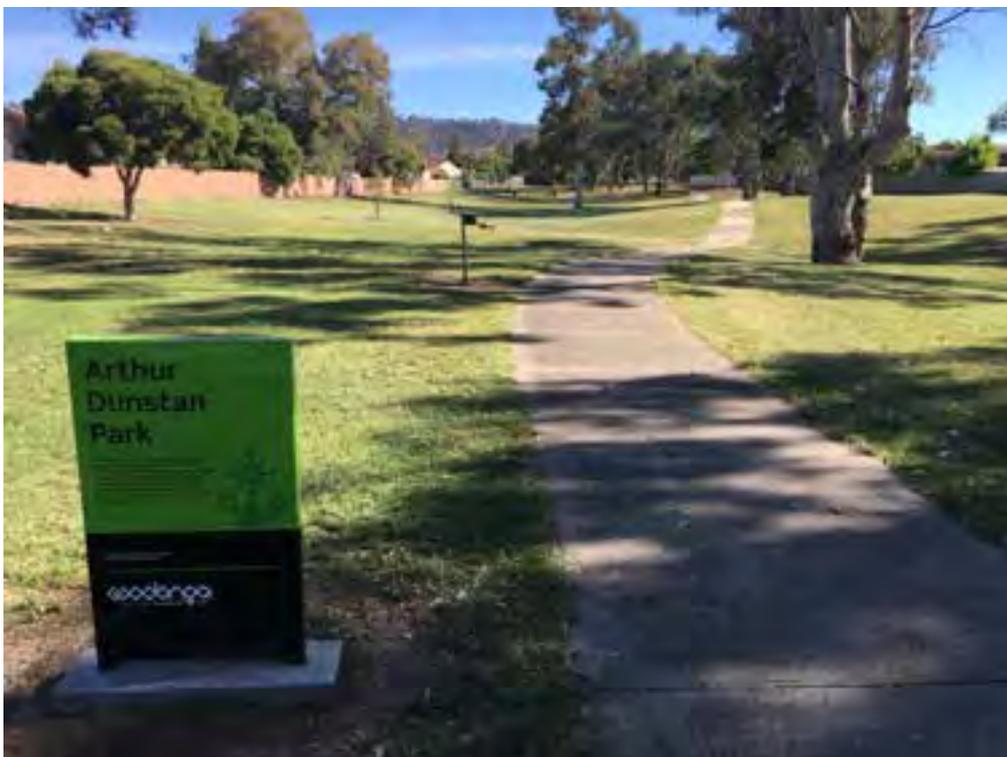
Jack-in-the-Box Creek exists as an underground pipe overlain by an open grassed swale throughout this reach (Figure 4-57). The grassed swale conveys flows greater than the pipe capacity. The underground pipe arrangement is very efficient at conveying water, sediments and any pollutants that are collected from the contributing catchment. The pipe presents a physical barrier for amphibious and aquatic fauna to migrate in Jack-in-the-Box.

Figure 4-57 Jack-in-the-Box Creek grass swale in Arthur Dunstan Park.

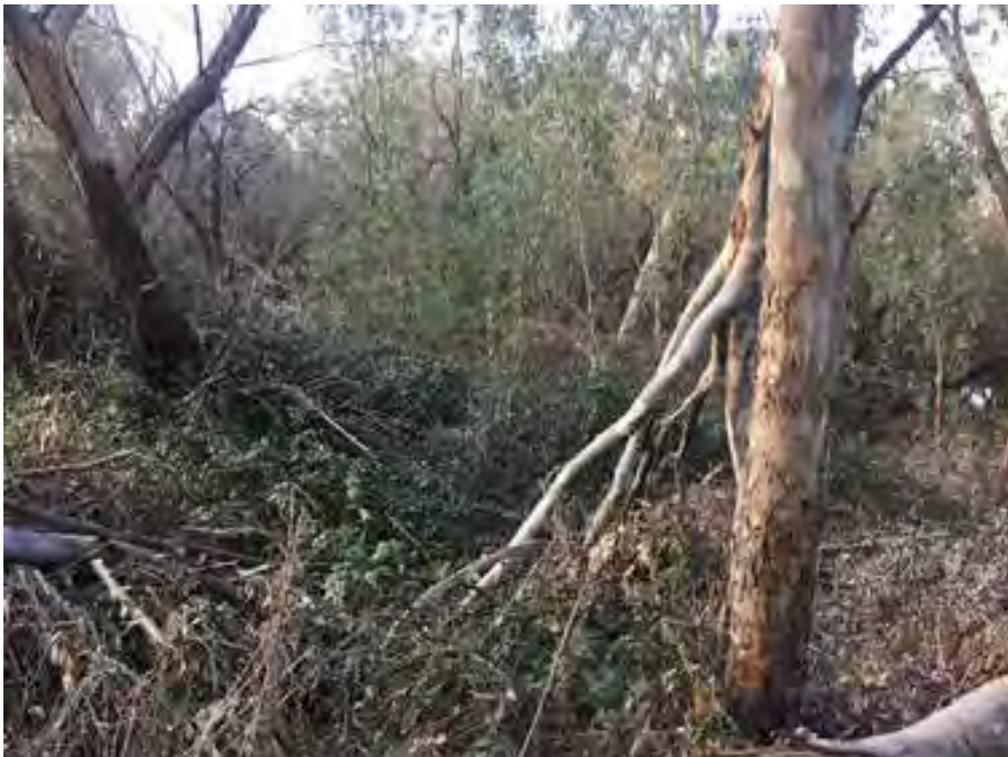
The woody riparian vegetation from Osburn past Kendall Street to the old railway line is almost exclusively exotic (Figure 4-59). There are patches of Red Gum canopy trees close to the old rail line and on the downstream side of the freeway to Wodonga Creek (Figure 4-60), however these patches are infested with Willow, Blackberry and Privet.

Figure 4-60 A Red Gum patch near the old railway line adjacent Jack in the Box Creek.
