Wodonga Regional Waterway Action Plan

Kookinburra Creek Condition Summary

Kookinburra Creek:

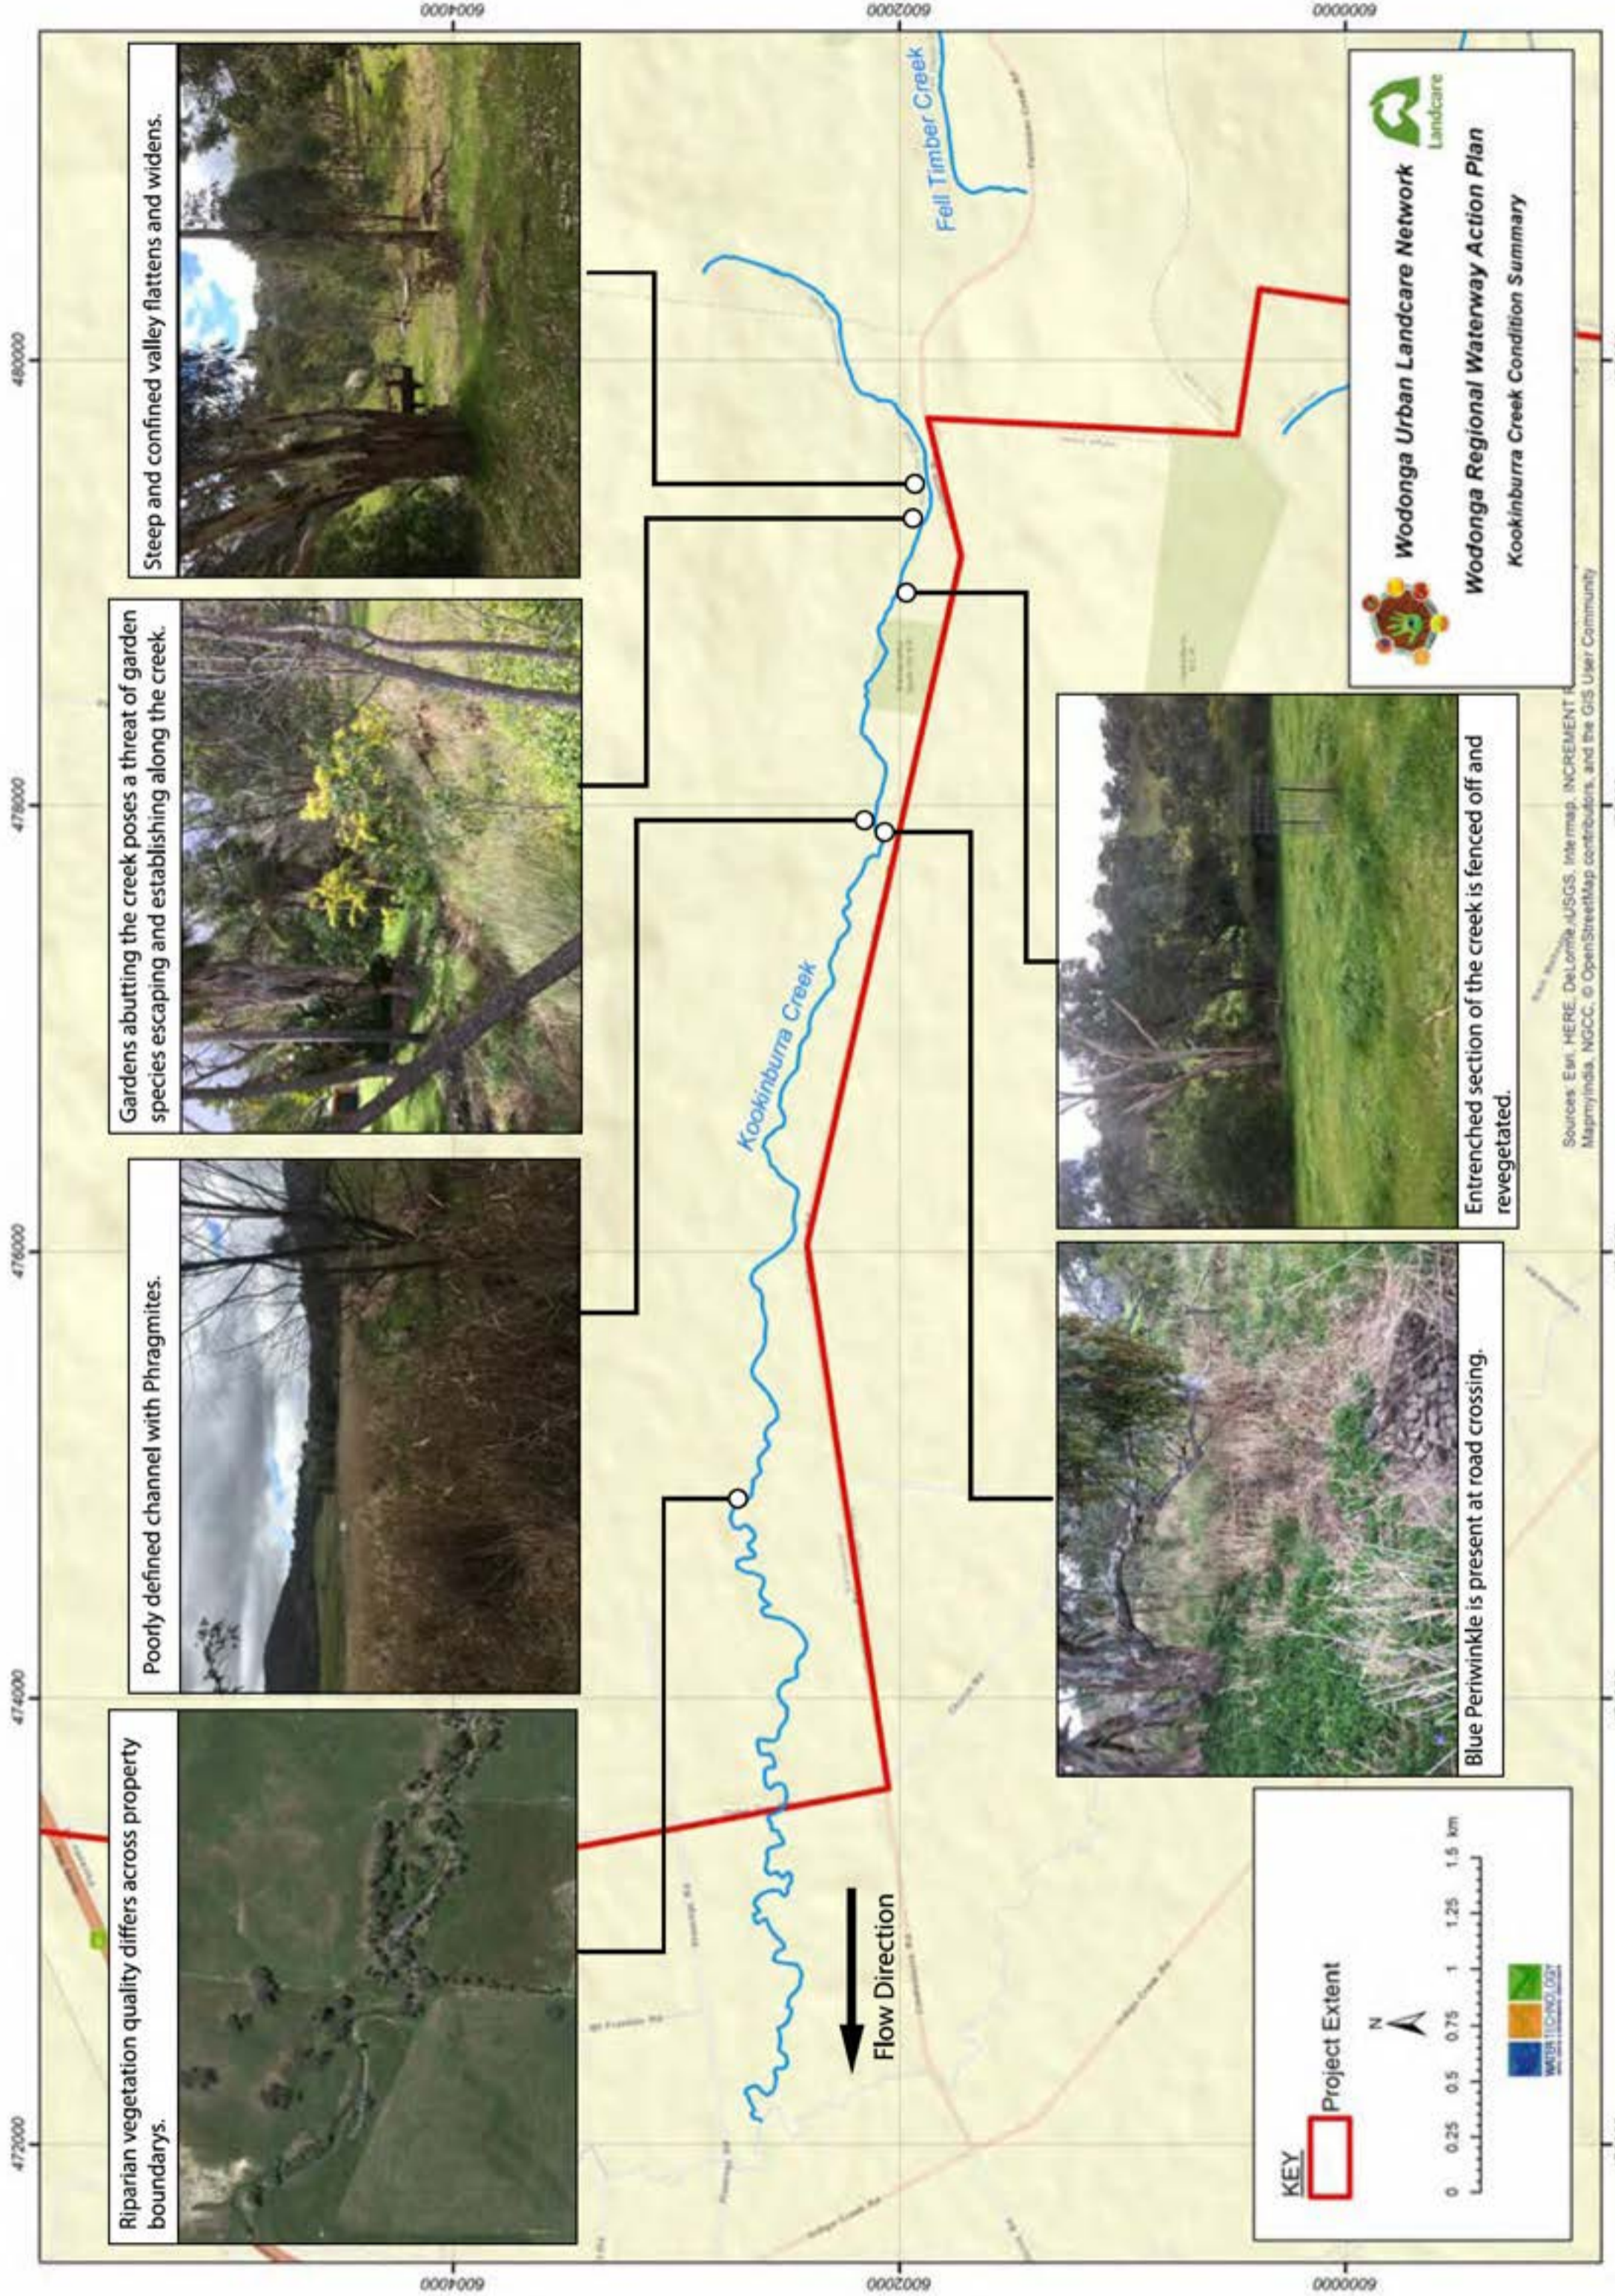
Riparian vegetation quality differs across property boundaries.

Poorly defined channel with Phragmites.

Gardens abutting the creek poses a threat of garden species escaping and establishing along the creek.

Steep and confined valley flattens and widens.

Blue Periwinkle is present at road crossing.

Entrenched section of the creek is fenced off and revegetated.
