Wodonga Regional Waterway Action Plan
 Middle Creek Condition Summary

WODONGA REGIONAL WATERWAY ACTION PLAN

Middle Creek:

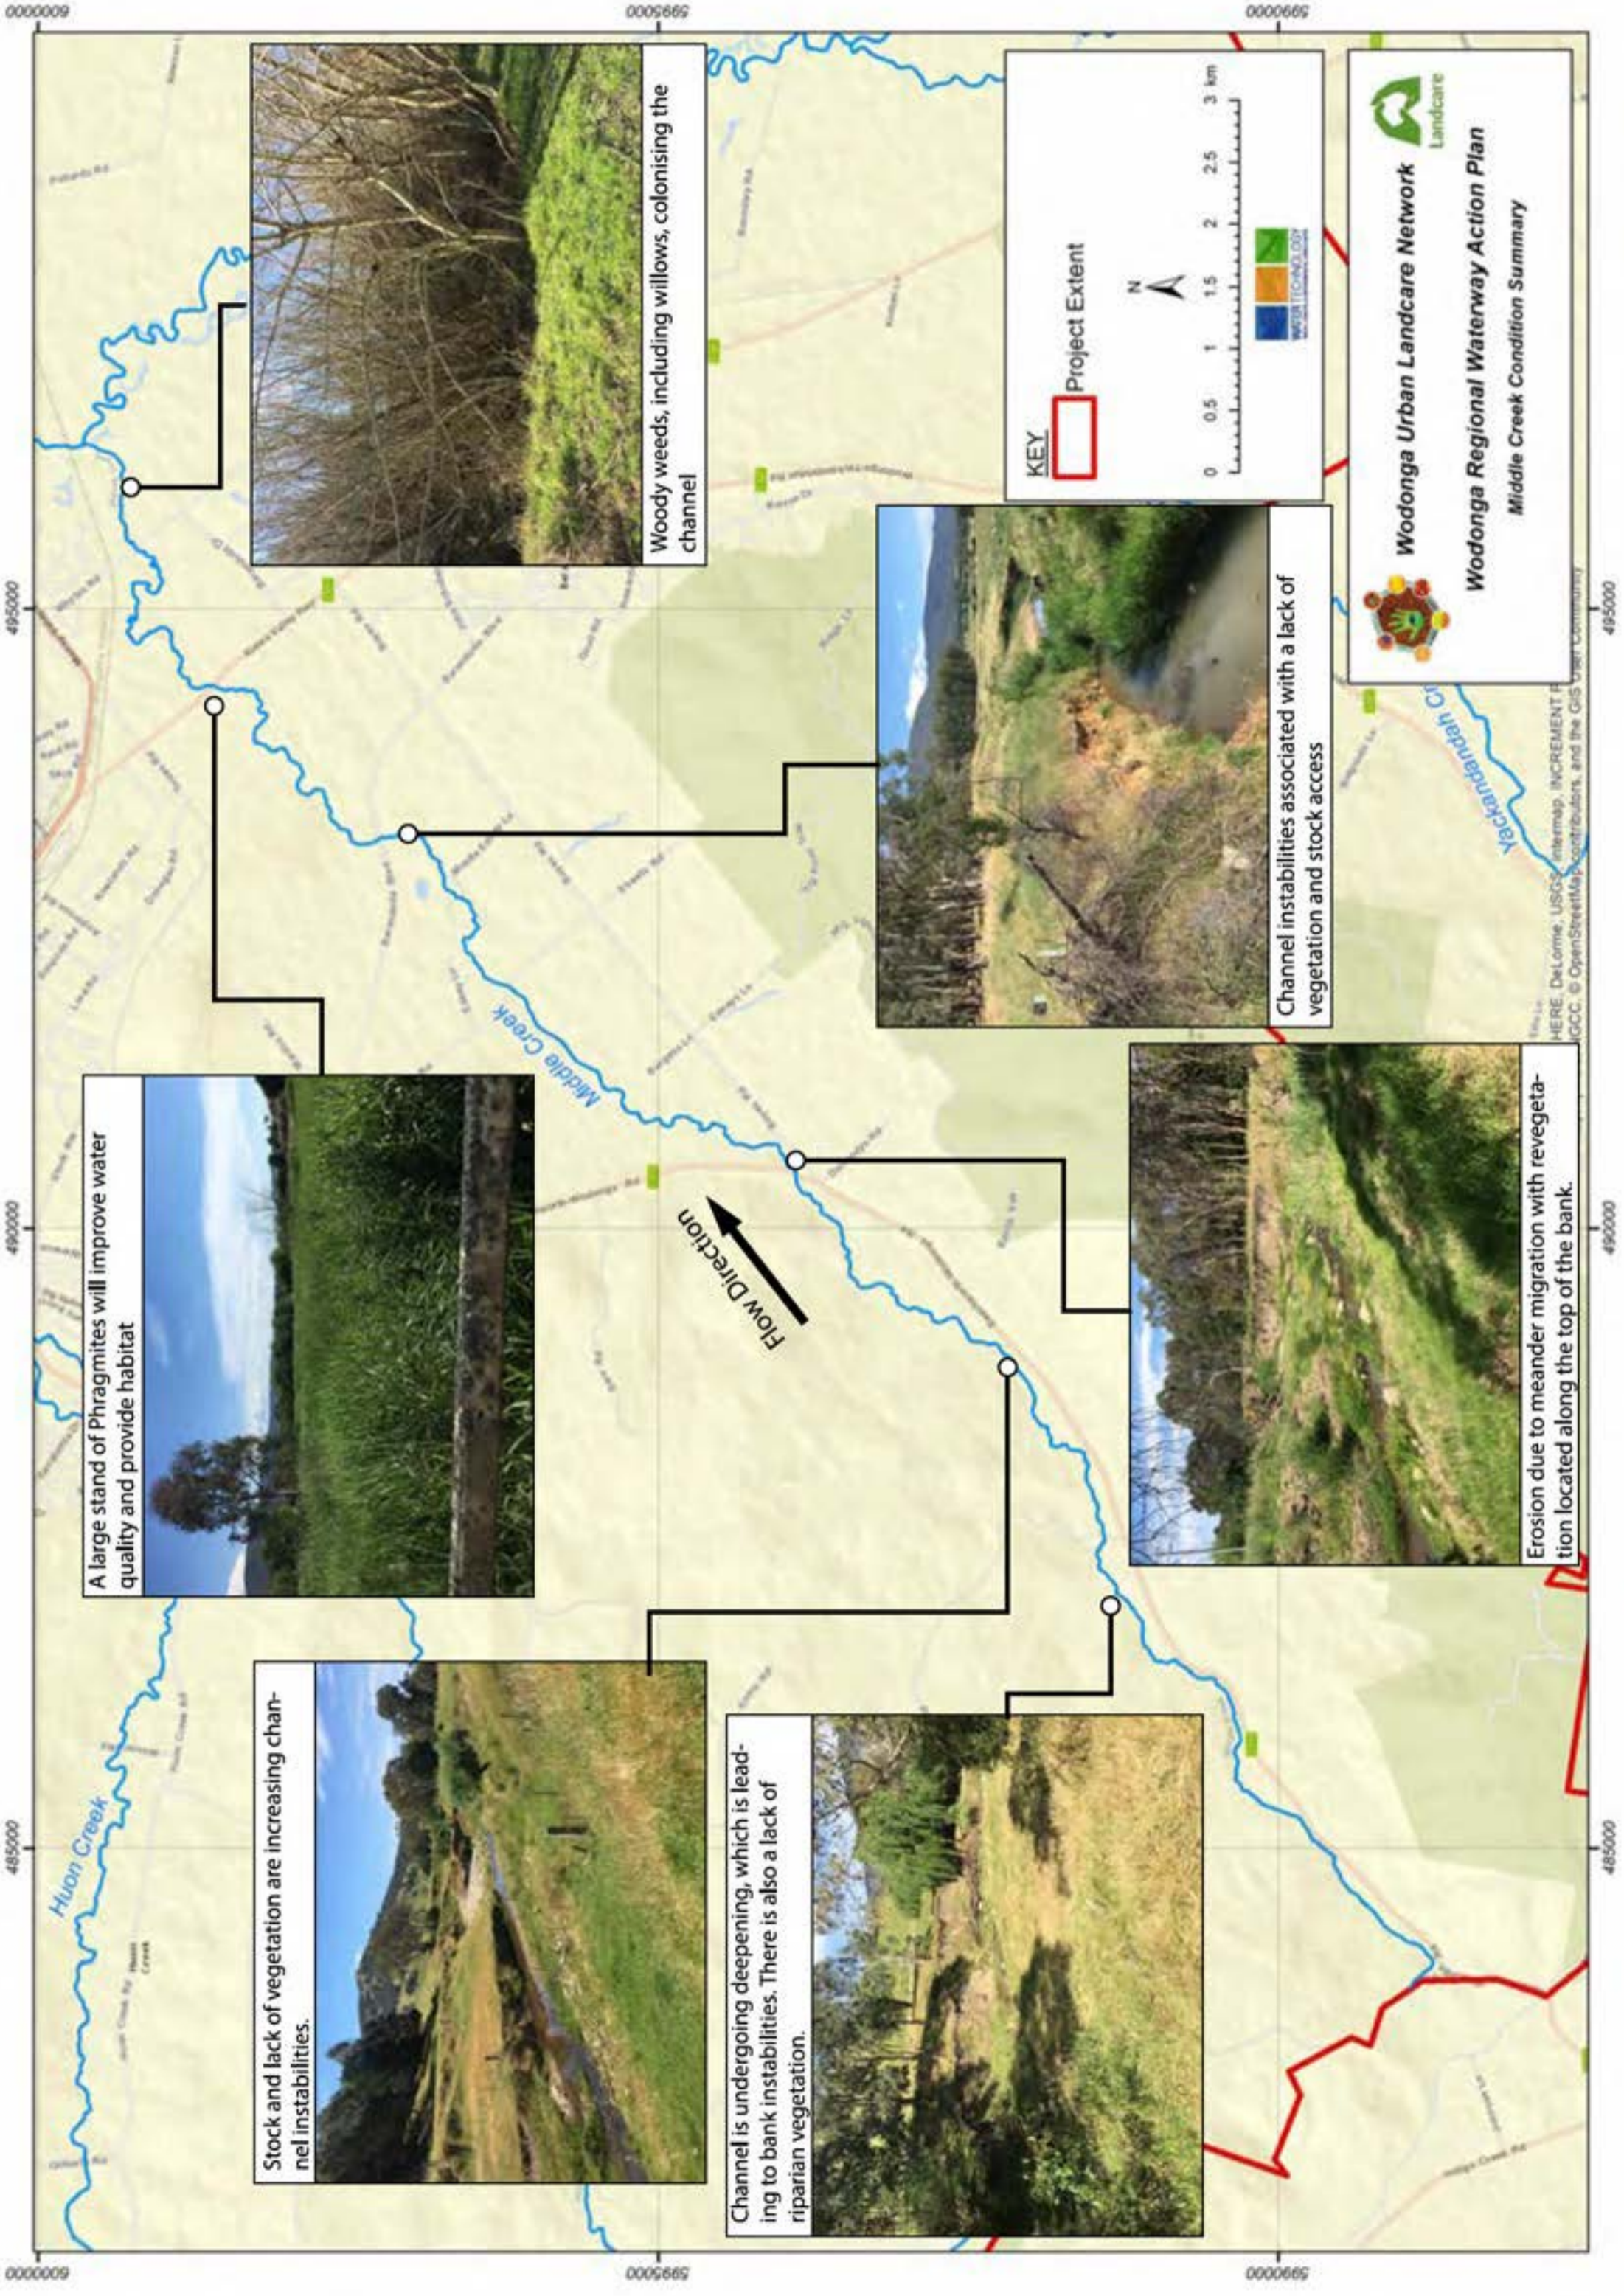
Erosion due to meander migration with revegetation located along the top of the bank.

Channel is undergoing deepening, which is leading to bank instabilities. There is also a lack of riparian vegetation.

Stock and lack of vegetation are increasing channel instabilities.

A large stand of Phragmites will improve water quality and provide habitat

Channel instabilities associated with a lack of vegetation and stock access

Woody weeds, including willows, colonising the channel

- *Stock Access Management and Revegetation* – Manage stock access to Middle Creek to enhance the condition of vegetation, improve the condition of banks, reduce physical pugging and sedimentation, and to improve water quality. Install offstream watering points where stock will lose access to water after fencing.

- *Bed and Bank Erosion Management* – Undertake a stability analysis of Middle Creek to determine if the bed deepening is active and the extent of bed deepening. This may lead to the design and construction of rock chutes to manage the deepening.

- *Exotic Flora Management* – Undertake exotic flora management activities with the aim to eradicate seeding woody weeds. Implement a recurrent work program to monitor and control regrowth of woody weeds within Middle Creek. Target other highly invasive weed species including blackberry. Priority areas: 1) continue to control weeds to protect the integrity of revegetation and protection works between Beechworth-Wodonga Road and Frederick Street Road, 2) Control woody weeds the lower section of the Mid Reach, 3) Control woody weeds in the Upper Reach, 4) Control willow and other woody weeds in the Lower Reach.

- *Revegetation Following Weed Management* – Undertake revegetation along Middle Creek to improve bank stability and the habitat and aesthetic value following the removal of weeds. In the Lower Reach, a 'swampy' riparian woodland EVC may be more appropriate for revegetation in the wetter areas of the floodplain.
